# LAVACA BASIN

## 2003 Basin Highlights Report

**LAVACA-NAVIDAD RIVER AUTHORITY**  
Prepared with the cooperation of the Texas Commission on Environmental Quality  
Clean Rivers Program

# LAVACA BASIN HIGHLIGHTS REPORT 2003

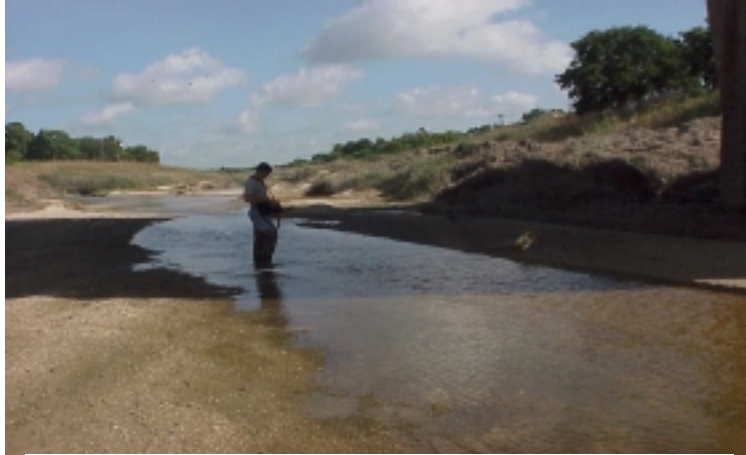
**Lavaca-Navidad River Authority employee Chad Kinsfather measures stream flow in the Lavaca River near Hallettsville, one of the water quality sites monitored by the Authority.**

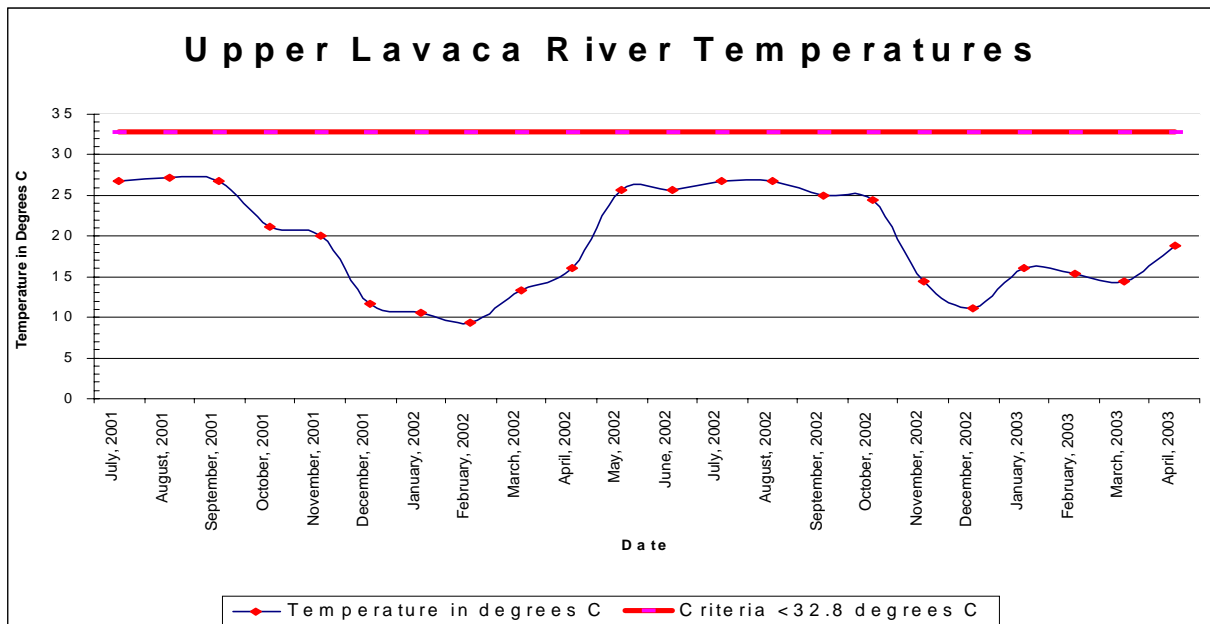
- ❖ Routine monthly water quality monitoring of field data at 18 sites located in the Lavaca River, Navidad River, Sandy Creek, East and West Mustang Creeks, Lake Texana, and Lavaca Bay.
- ❖ Routine quarterly conventional water sampling at 15 sites located throughout Lavaca Basin.
- ❖ Monthly field data collection and flow monitoring at Big Brushy Creek in Yoakum in support of that city's wastewater treatment plant permit.
- ❖ An ongoing special study in the upper reaches of the Lavaca River (Segment 1602) includes flow, field, and 24-hour dissolved oxygen studies.
- ❖ Dissolved oxygen 24-hour studies at 2 sites in upper Lake Texana (Segment 1604)
- ❖ Constant remote temperature sensing in the upper Lavaca River (Segment 1602) with monthly reporting to TCEQ. Monthly data is shown in Figure 2 below.

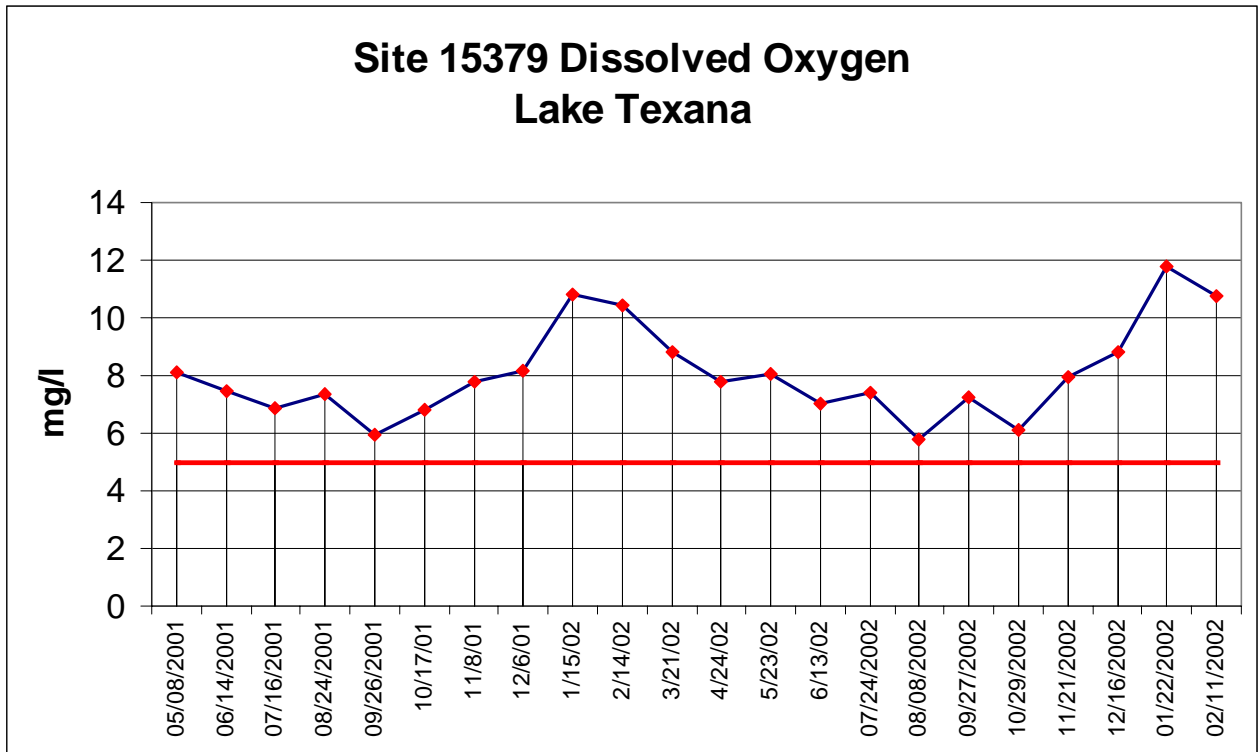
A special study for dissolved oxygen (discussion page 12-14) is being conducted in the Navidad River/Sandy Creek and Mustang Creek arms of the reservoir. However, in the main body of the lake, as shown by the instantaneous readings graphed in Figure 4 below, dissolved oxygen is being sustained at a healthy level well above the 24-hour DO criteria of 5mg/L (criteria line shown on graph).

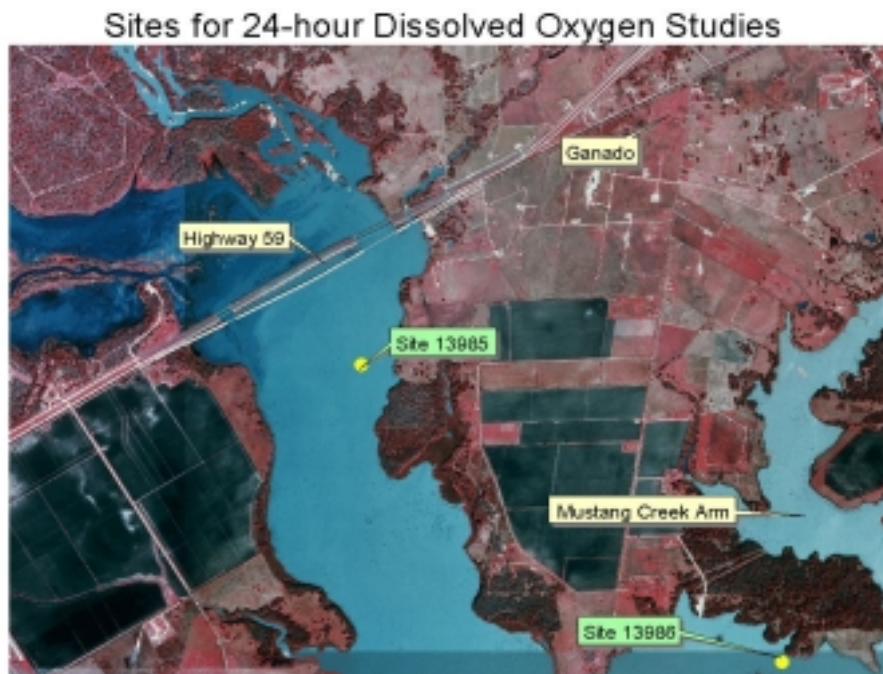
The 1998 303d List of Impaired Waters included Lake Texana (Segment 1604) for occasional exceedences of the dissolved oxygen criteria to support aquatic life at two sites in the upstream sections of the Lake. In an effort to remove it from the list, LNRA began 24-hour dissolved oxygen studies in 2001. Locations of the two sites are shown on the map below (**Figure 5**).

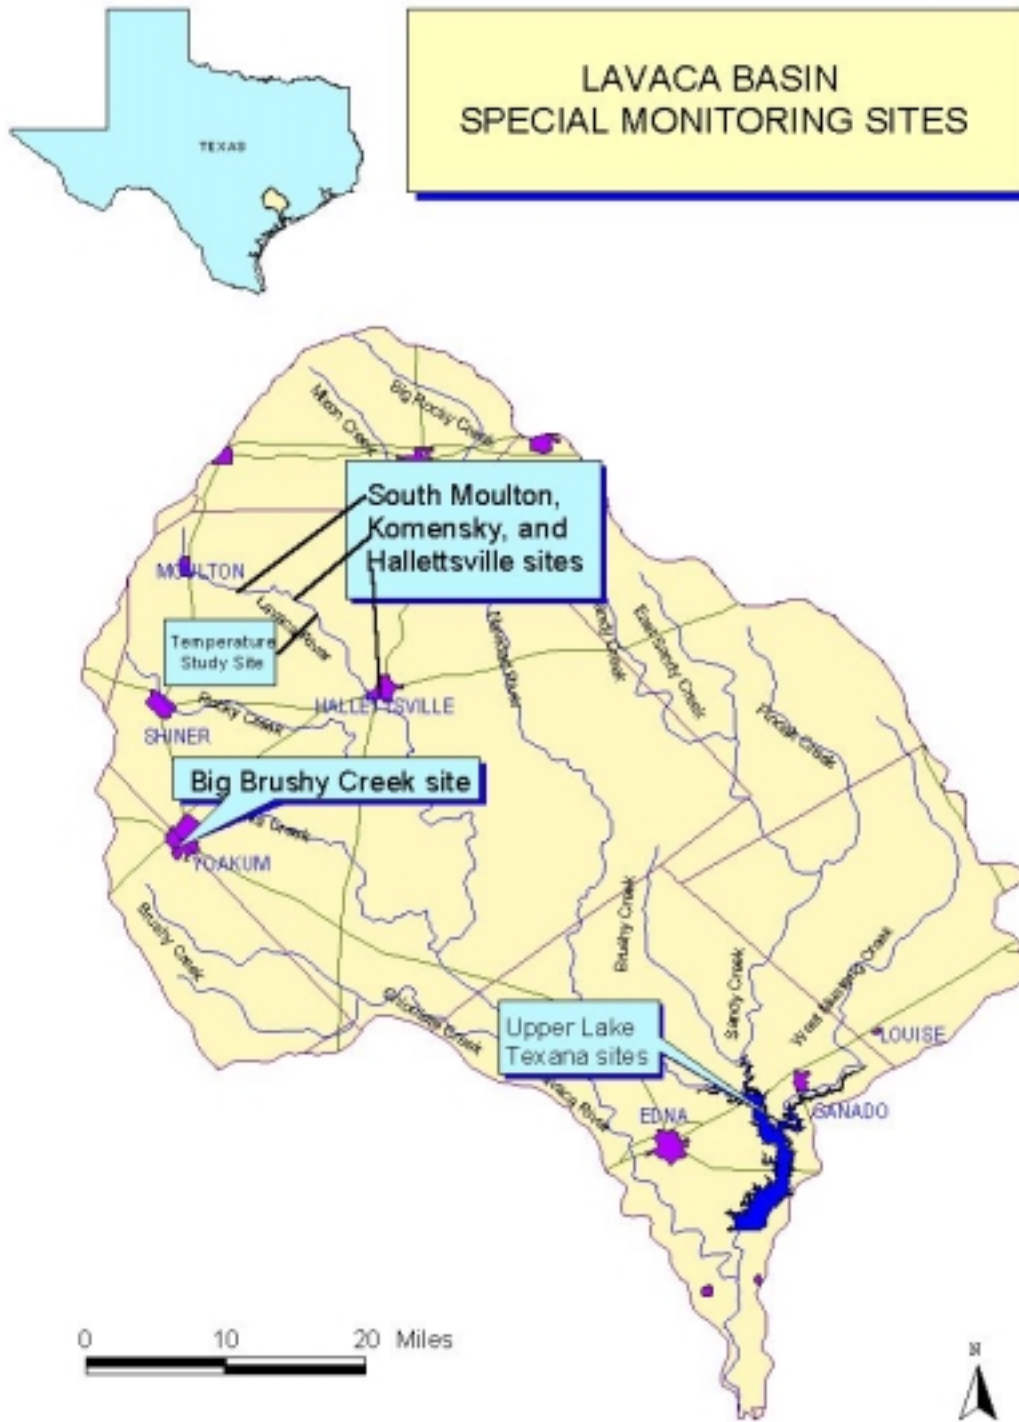
Location of Special Study monitoring stations is depicted in Figure 6 on the following page.

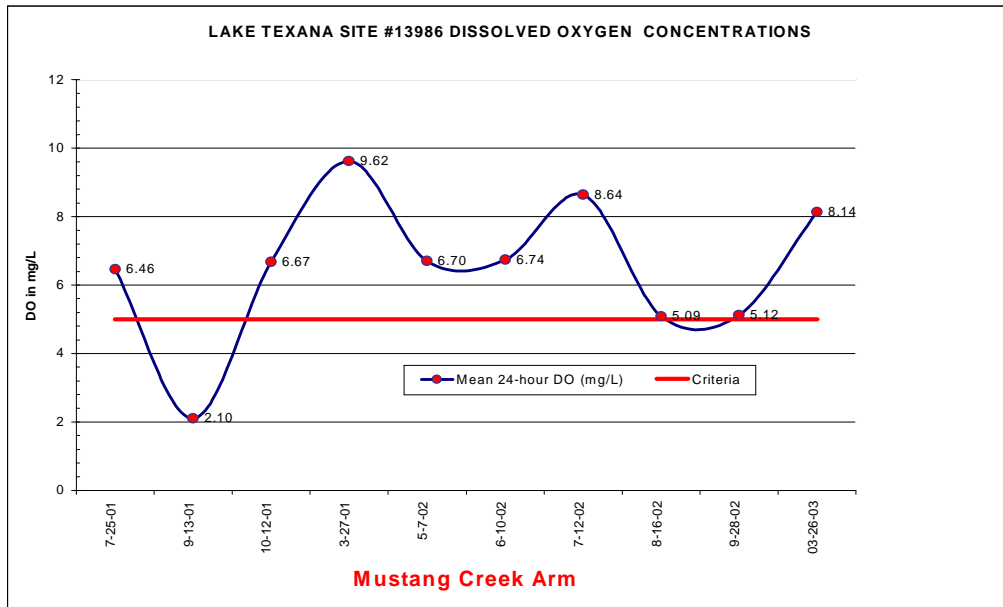
**Figure 7**

To date, ten independent 24-hour DO studies have been completed during the Index (March 15-October 15) and Critical (July 1-September 30) Periods. One out of the ten sampling events yielded dissolved oxygen values below the 24-hour mean and minimum DO criteria of 5mg/L and 3mg/L respectively. This event occurred in September 2001 when the reservoir level had been low. Over 16 inches of rain fell in the watershed during a period of only a few days. Resulting runoff carried heavy organic debris loads into Lake Texana. The sharp decline in dissolved oxygen levels may indicate that bacterial decomposition of these organic loads consumed oxygen in the water column. By the next month dissolved oxygen levels had recovered in the reservoir. The charts below (Figures 7 and 8) display mean concentrations of dissolved oxygen measured at the two sampling sites in upper Lake Texana.

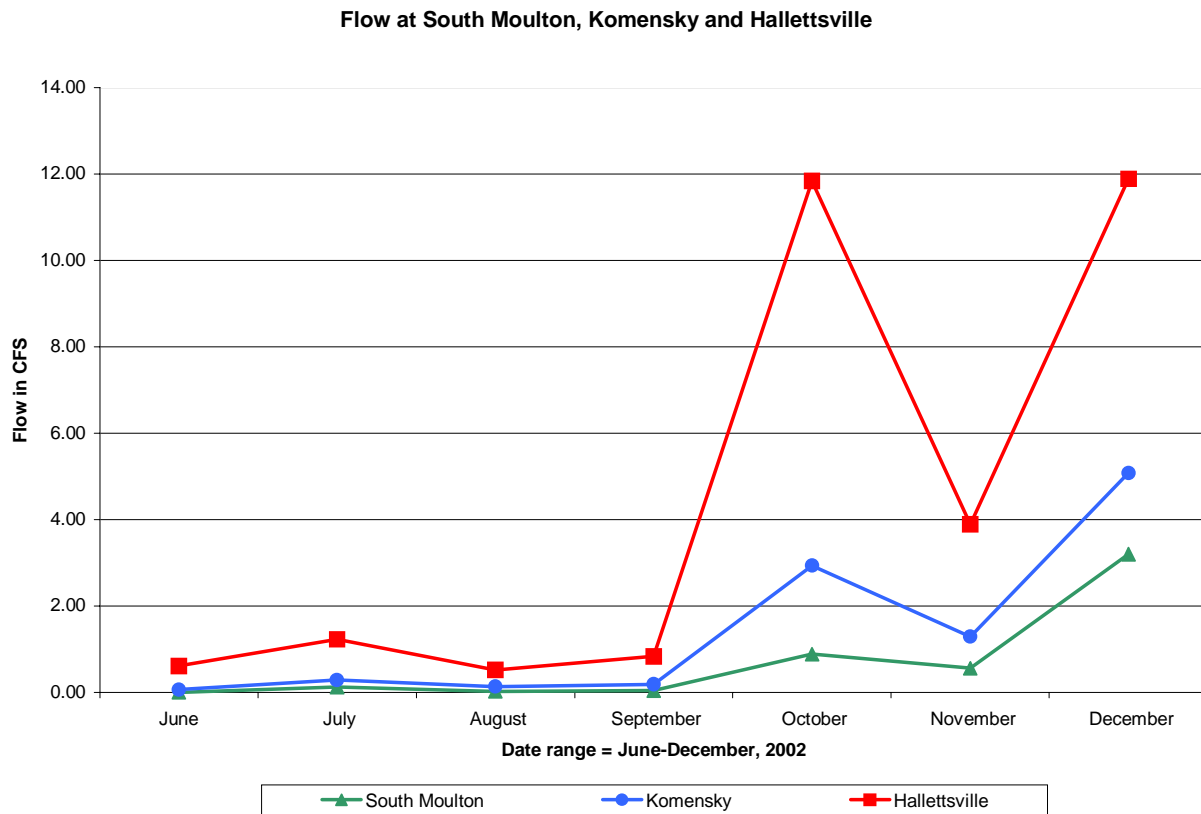
**Figure 9**

LNRA is currently conducting a special study in the upper reaches of the Lavaca River as part of a contract amendment with the Clean Rivers Program. In the past there has been very little study in this area, but data have indicated intermittent flow to be the cause of low dissolved oxygen concentrations. Monthly flow studies are being conducted at three sites: South Moulton site #17595, Komensky site #17594 and Hallettsville site #12527. Flows in this area are very low except during rain events. The dynamic nature of these flows can be seen in the graph of the preliminary data below:

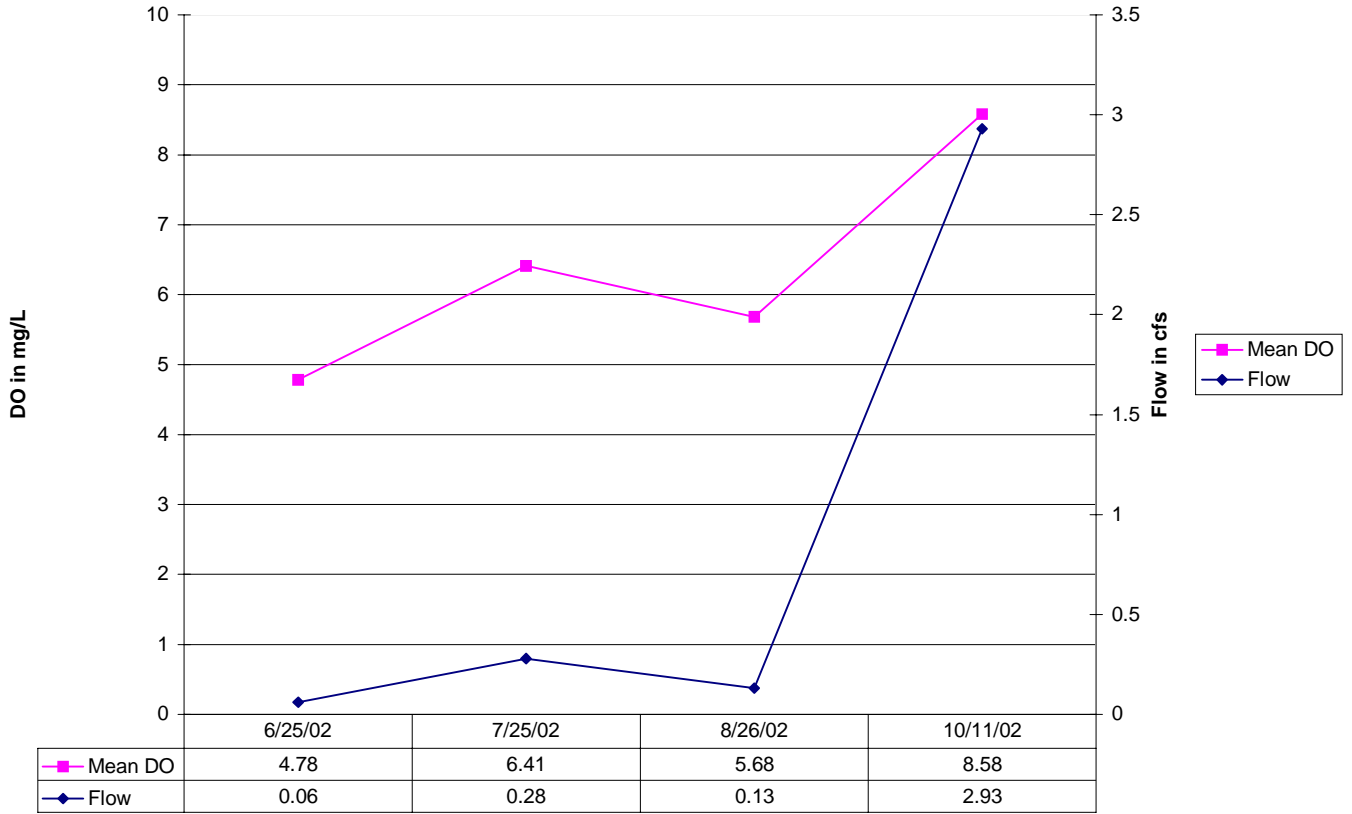
**Figure 10**

Ten twenty-four hour dissolved oxygen studies are being conducted during the Index and Critical Periods at the Komensky site. Four of these 24-hour events have been completed. Preliminary data show a strong correlation at this site between dissolved oxygen and flow, i.e. dissolved oxygen increases with higher flow. This data is shown in Figure 10 on the following page.

**Komensky 24-hour DO**

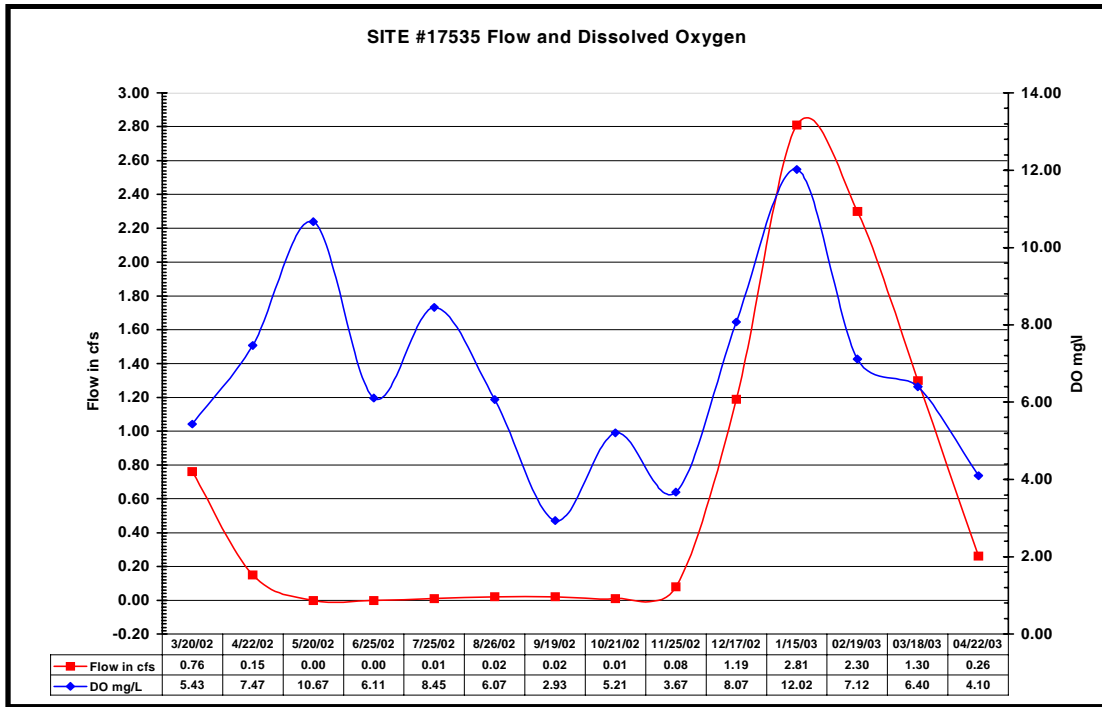
Figure 11

This same correlation of dissolved oxygen and flow has not been observed at the Yoakum study site (#17535) at Big Brushy Creek. Monthly flow and instantaneous field data are being collected for at least twelve (12) consecutive months in support of that city’s wastewater treatment plant (WWTP) permit renewal. Field and flow measurements are collected upstream of the outfall of the Yoakum WWTP. On the following page are Figures 11 and 12 comparing the dissolved oxygen concentrations both with flow and temperature. One might expect an increase in dissolved oxygen with higher flows and/or with lower water temperatures. However, this relationship is not consistently observed at this site.

During one sampling event on May 20, 2002, DO was measured to be 10.67 mg/L during low flow conditions. Abundant green algae could be a contributing factor to the high DO concentration. More data is needed to explain the variation in dissolved oxygen.
