# *2018 Lavaca Basin Highlights Clean Rivers Program Report*

*Prepared by the  
Lavaca-Navidad River Authority (LNRA)  
PO Box 429, Edna, TX 77957*

# **LAVACA BASIN HIGHLIGHTS REPORT 2018**

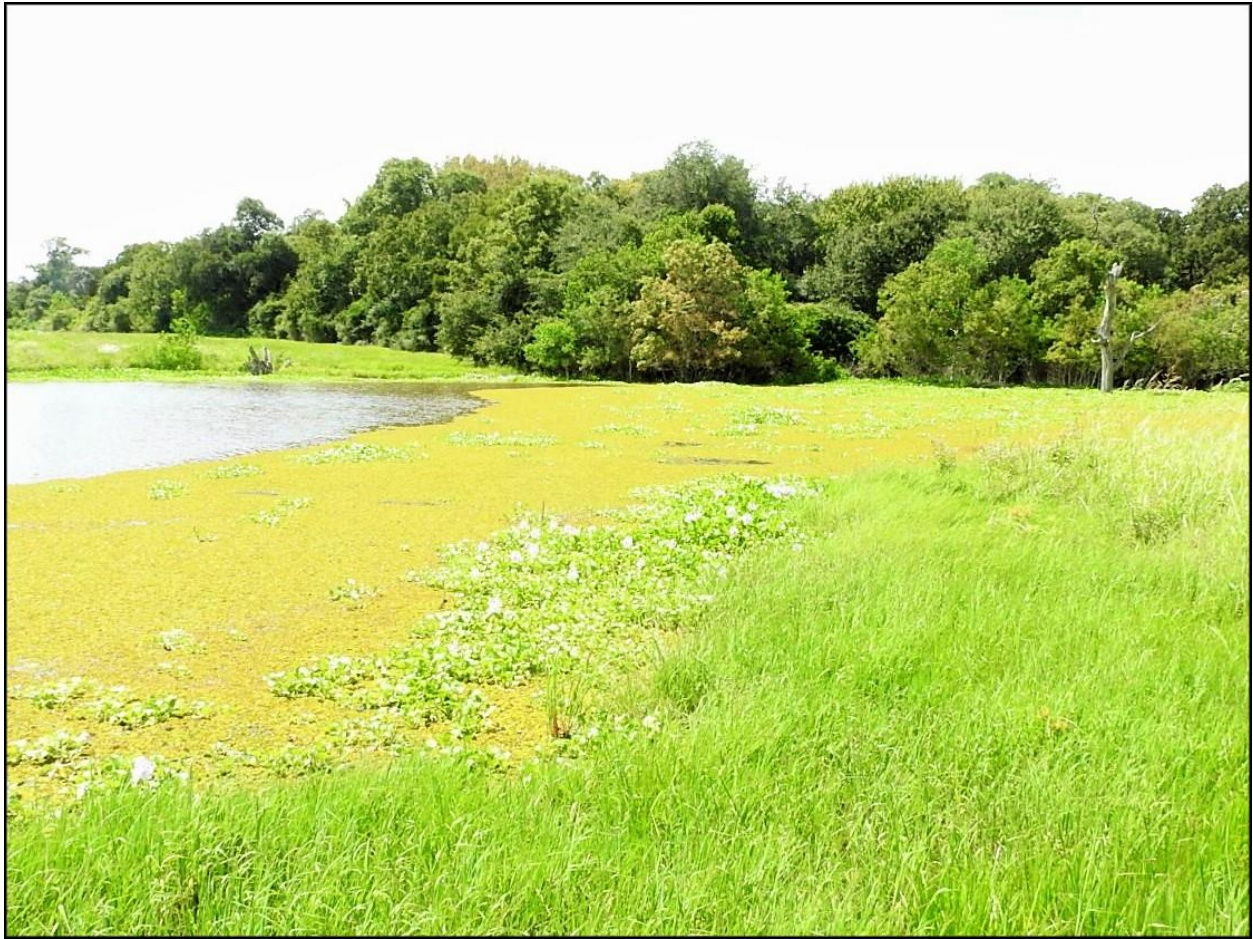
*Figure 5-Giant Salvinia at Texana Cove Before Weevil Release*

In September 2016, TPWD delivered 11,939 adult Salvinia Weevils to Lake Texana where they were placed in a designated test site within LNRA's Texana Park. The test site was a secluded cove, separated from the main body of the reservoir. The chosen site was infested with adult and juvenile Salvinia plants and was considered an ideal location to establish a viable Salvinia Weevil population.

Beginning in December 2016, LNRA conducted monthly visual inspections of the test site to observe Salvinia degradation and inspected plants to verify the presence of weevils. With each inspection, it was observed that the overall mass of Salvinia was being reduced and the weevil population was thriving. As the reader will note from the photos in Figures 5 and 6, the introduction of Salvinia weevils, when used as a management tool, can be highly productive in controlling this challenging invasive plant species. To this day, the Salvinia has not recovered in the cove.

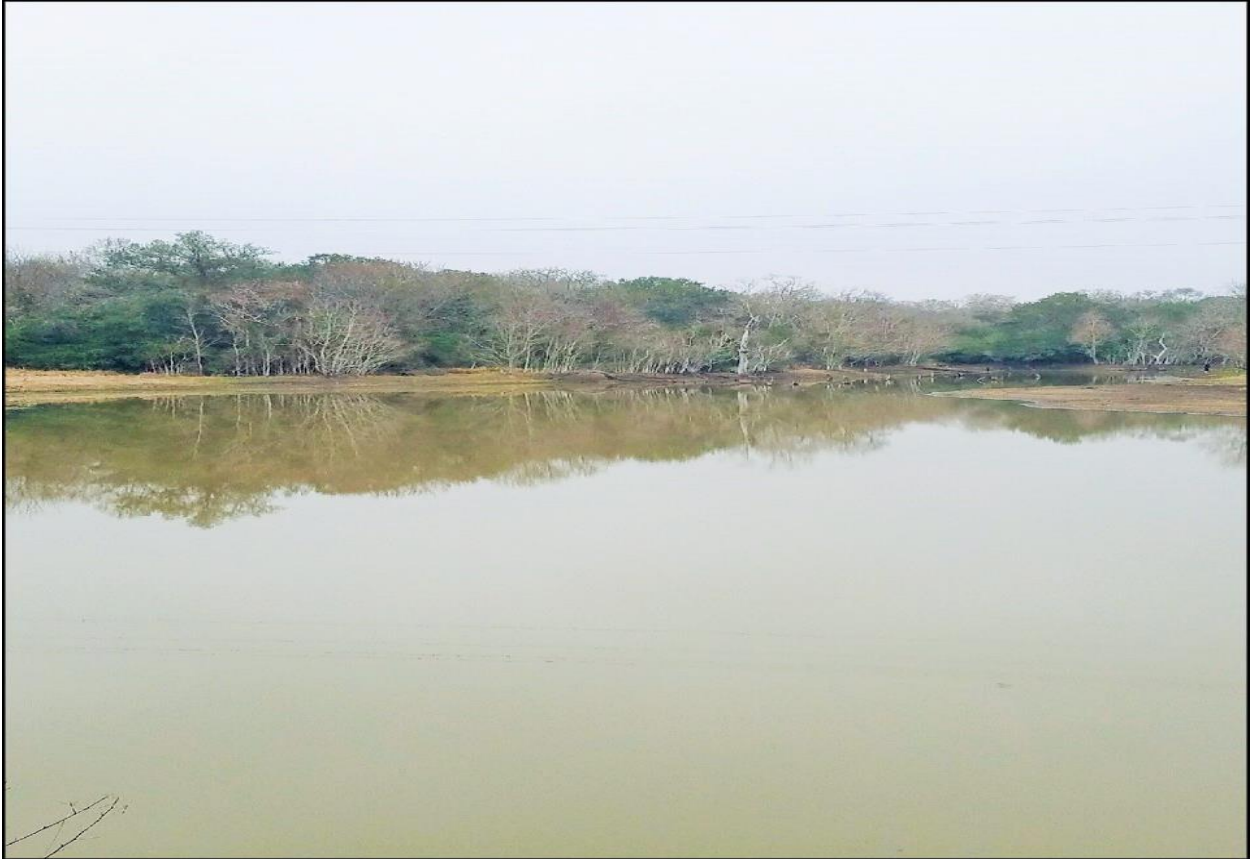
*Figure 6- Texana Cove 2 Years After Weevil Release*
