# 2020 Lavaca Basin Highlights Clean Rivers Program Report

*Prepared by the  
Lavaca-Navidad River Authority (LNRA)  
PO Box 429, Edna, TX 77957*

# LAVACA BASIN HIGHLIGHTS REPORT 2020

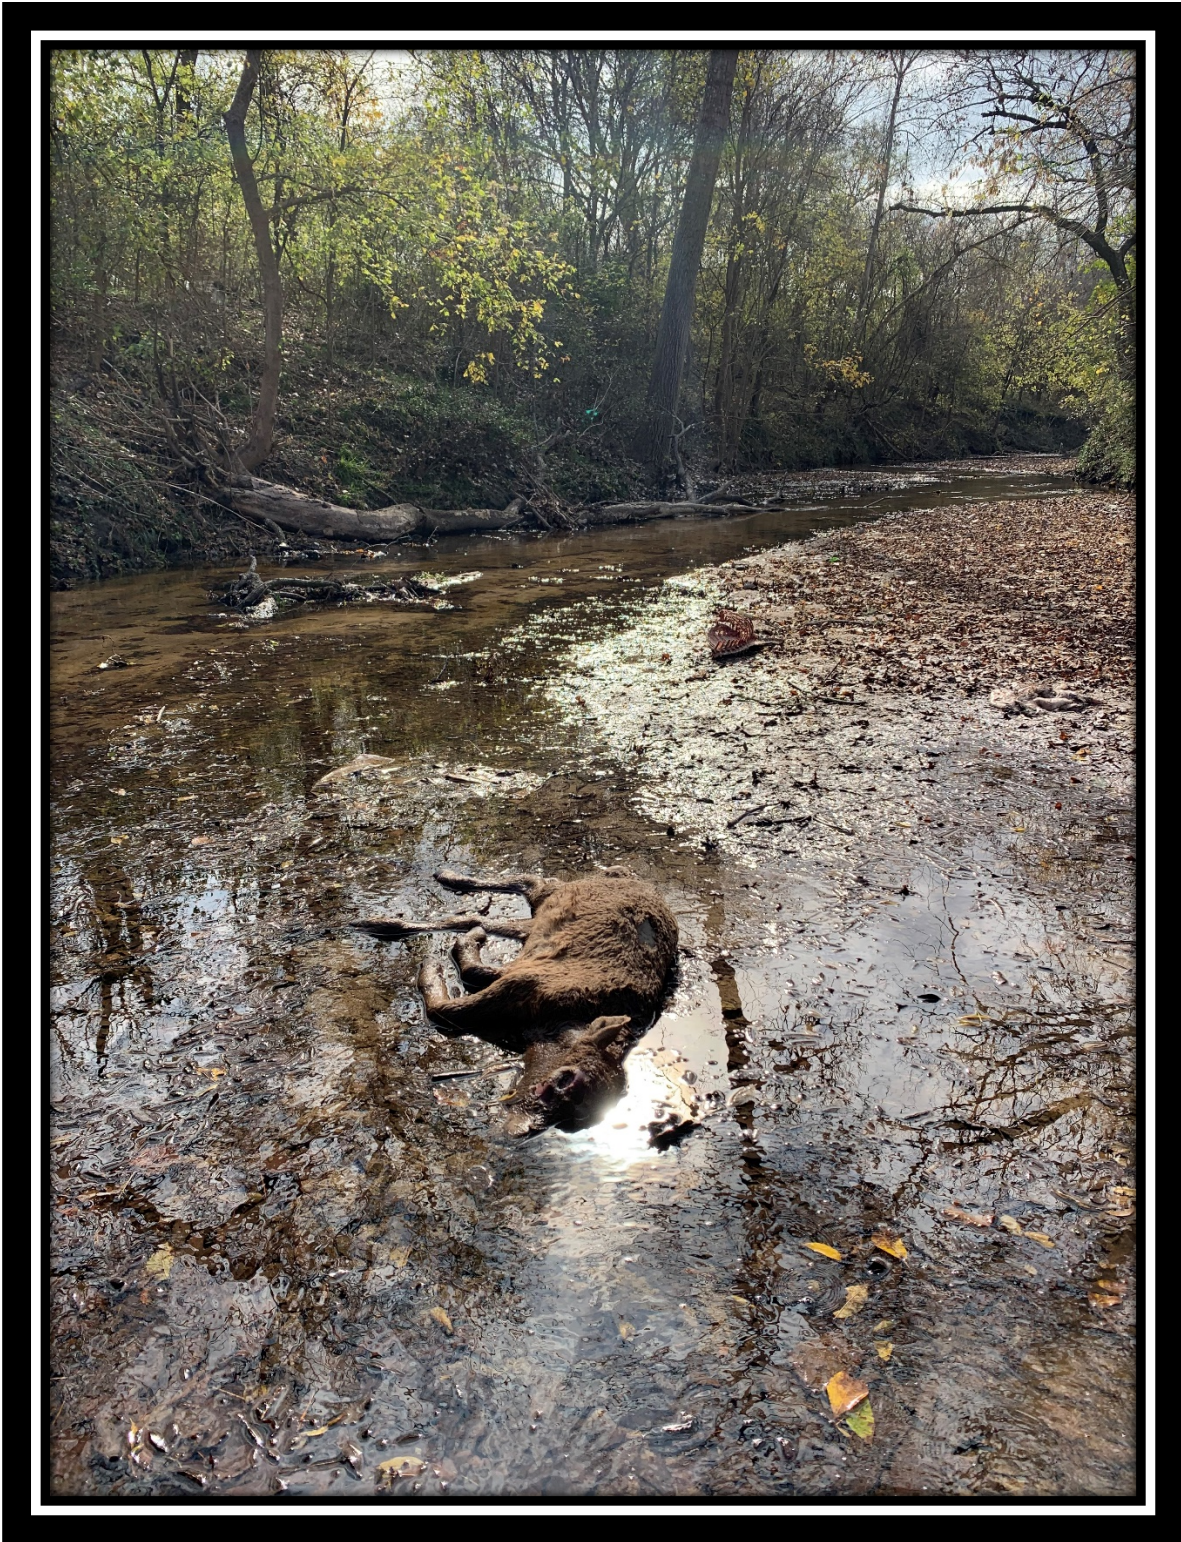
Figure 3: Dumping of livestock in Rocky Creek downstream of LNRA sample site.

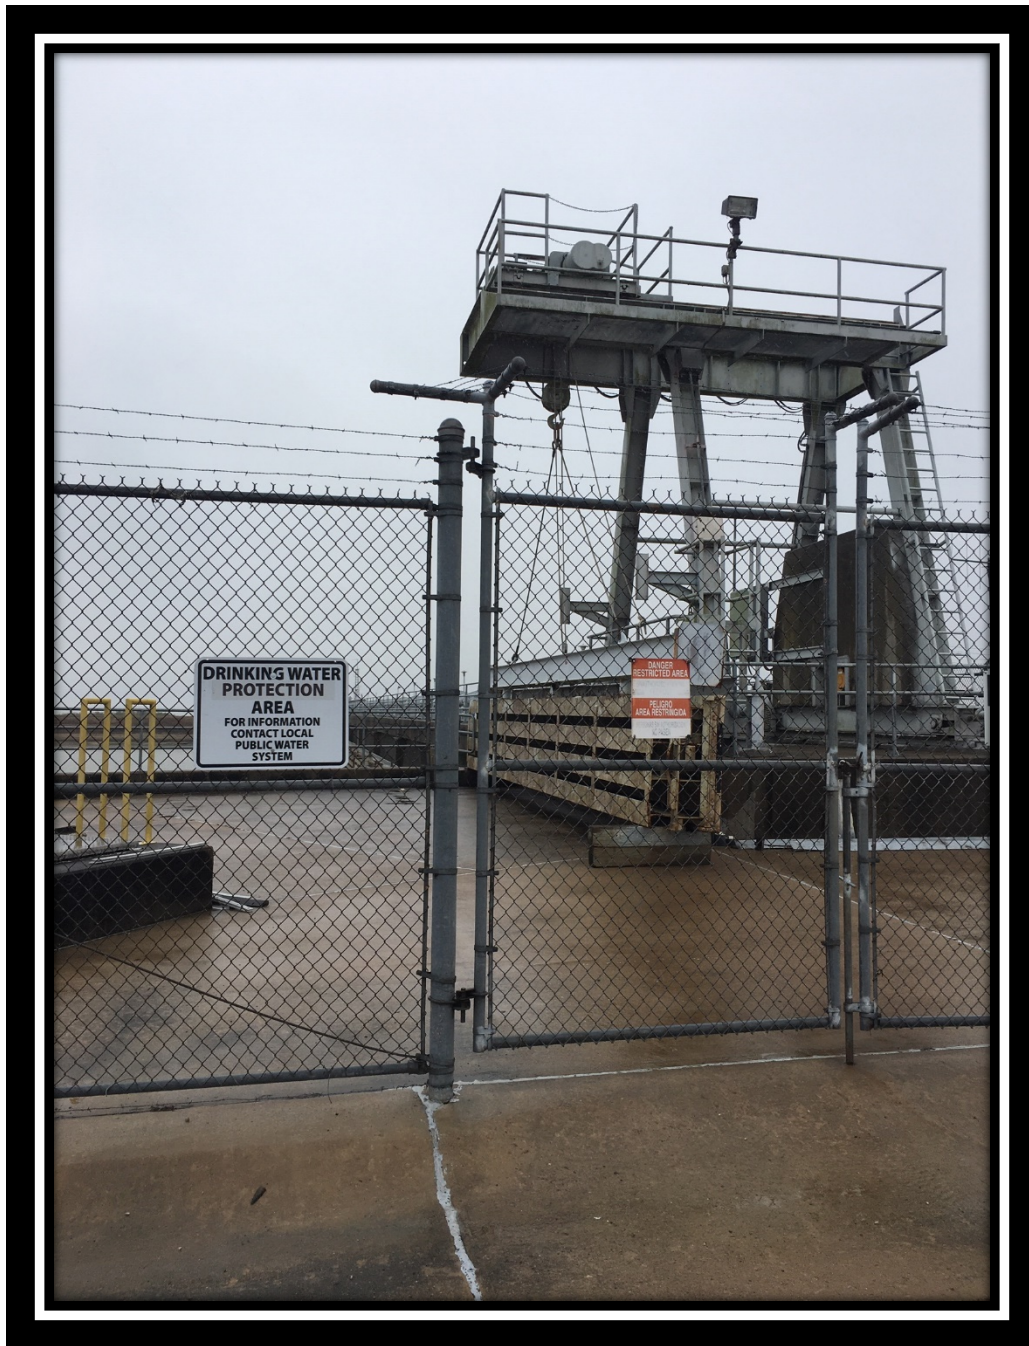
Figure 4: Source Water Protection Signage at Palmetto Bend Dam.

Source water protection is one approach that can be taken in order to ensure we are providing safe drinking water.

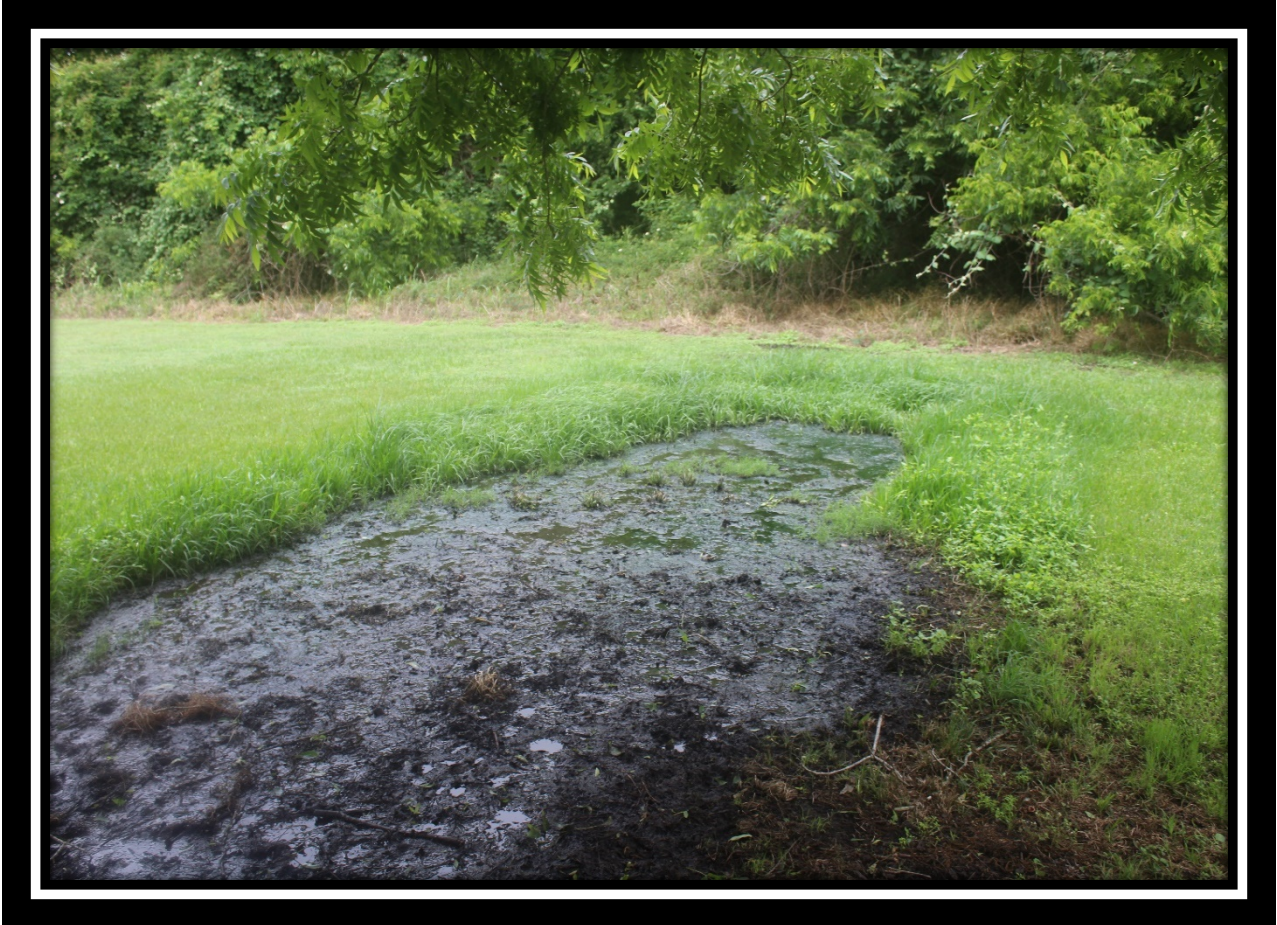
Figure 5: "Greywater" released by failing OSSF.

LNRA employees visited the locations to investigate the on-site sewage facilities and to collect data on the site locations, assess the severity of seepage, and capture photos. Upon investigation, it was evident that the on-site sewage facilities were inadequately operating. The reported leaks were said to be simple grey water discharges from the systems. This can be caused by hydraulic overloading. Hydraulic overloading is caused when the incoming wastewater exceeds the systems flow rate. As a result of hydraulic overloading, bacteria in the system can be reduced, which reduces the effectiveness of the water treatment process. With reduced numbers of bacteria in the system this means fewer solids are being broken down resulting in excess solids passing into the drain field. Although it is legal to discharge greywater, current regulations state that wastewater that is managed by an on-site sewage facility may not leave the property where it is generated. The wastewater discharge from these on-site sewage facilities had begun to accumulate on LNRA property. Once it was confirmed that these systems were failing, post owner notification, a report was filed with the Jackson County Office of Permitting & Inspection. LNRA performed an inspection visit to the sites to ensure proper measures were taken to resolve the failing systems. Upon the second visit it was noted that appropriate measures had been taken by the County and landowners.

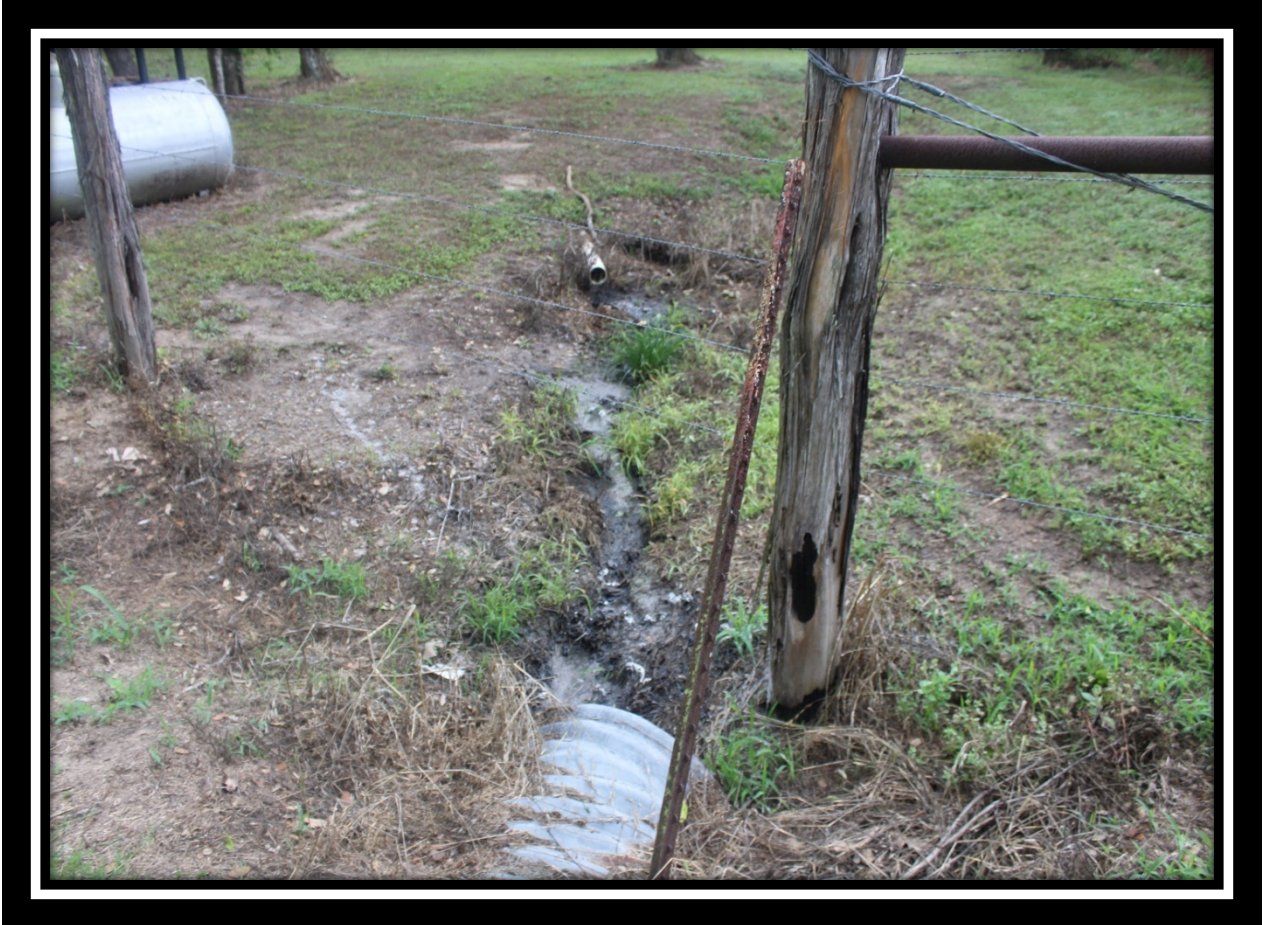
Figure 6: Wastewater effluent stream being illegally diverted across property lines.

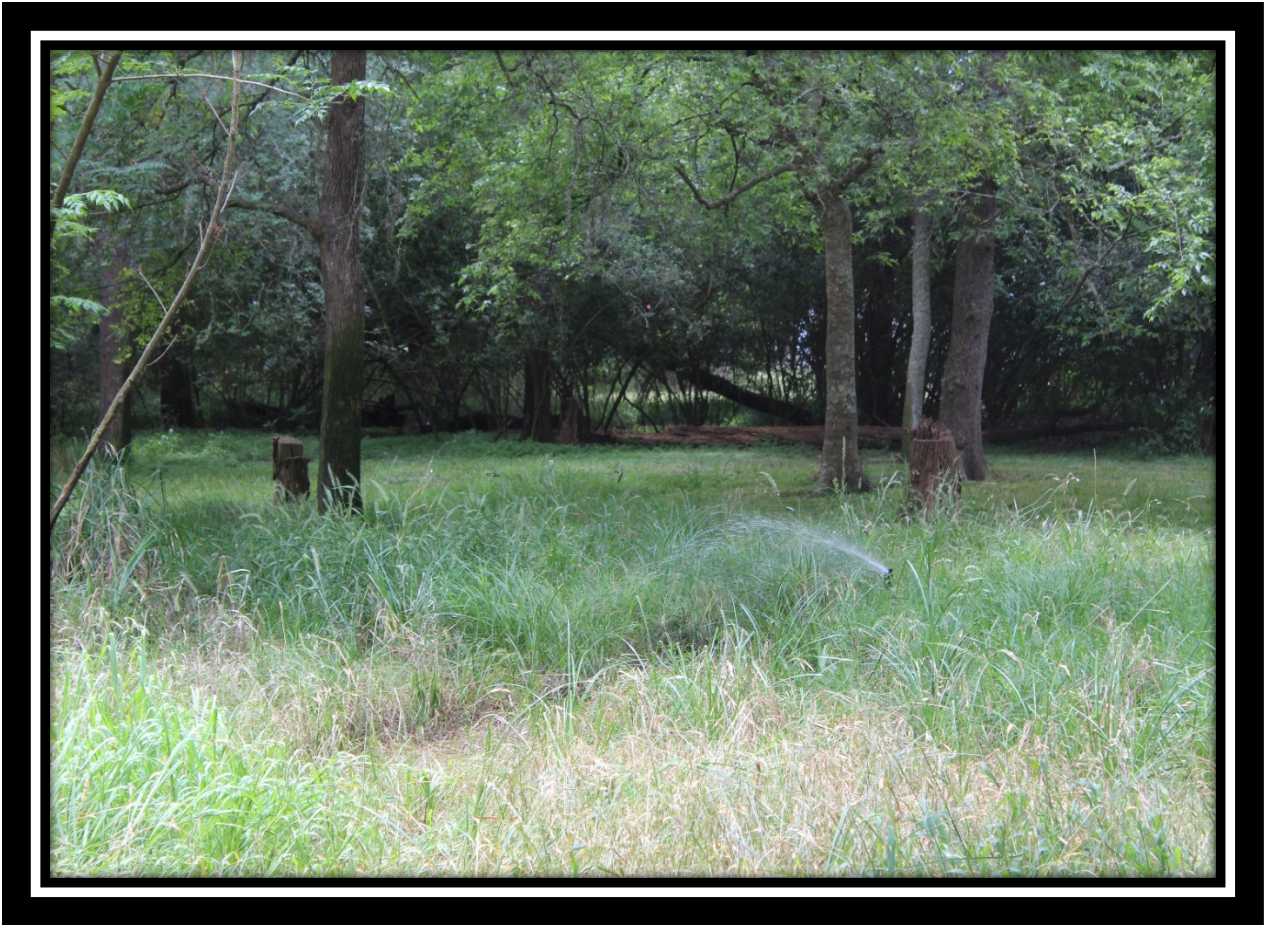
Figure 7: Hydraulic overloading of wastewater discharge system.
