Lavaca Basin

2021 Water Quality Update

*Prepared by the
Lavaca-Navidad River Authority (LNRA)
PO Box 429, Edna, TX 77957*

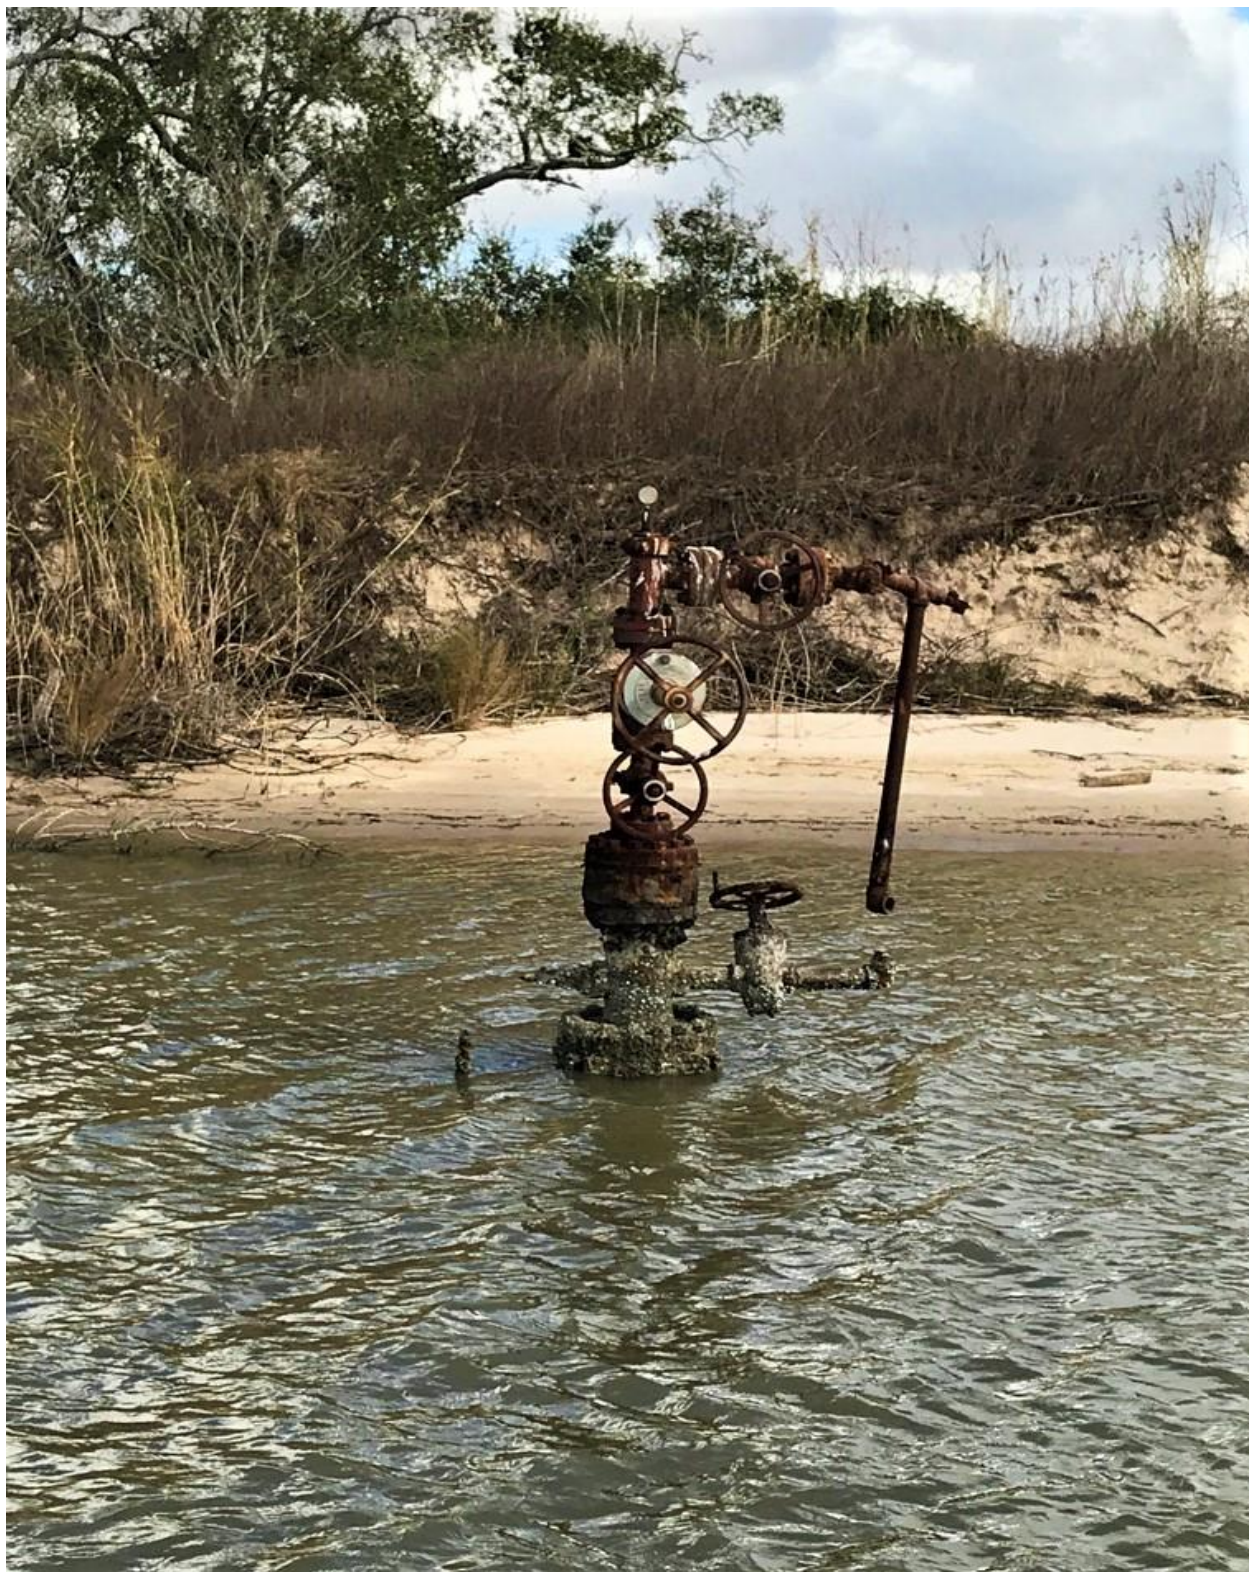
Figure 8: Abandoned Oil Well Number One.

The two (2) abandoned oil wells located on the Lavaca River (Figure 7) are an example of abandonment by an oil producer. Both wells are located roughly 3.5 miles downstream of FM 616 on the Lavaca River in Jackson County. For many years the wells were situated on dry land, but flooding and tidal action has eroded the adjoining bank, leaving the wells located in the river channel. The Jackson County Navigation District estimates that these wells may have been drilled in the 1930's. There is no record of current ownership. Left unchecked, these abandoned wells pose a real threat to the Lavaca River and the estuary they are situated in.

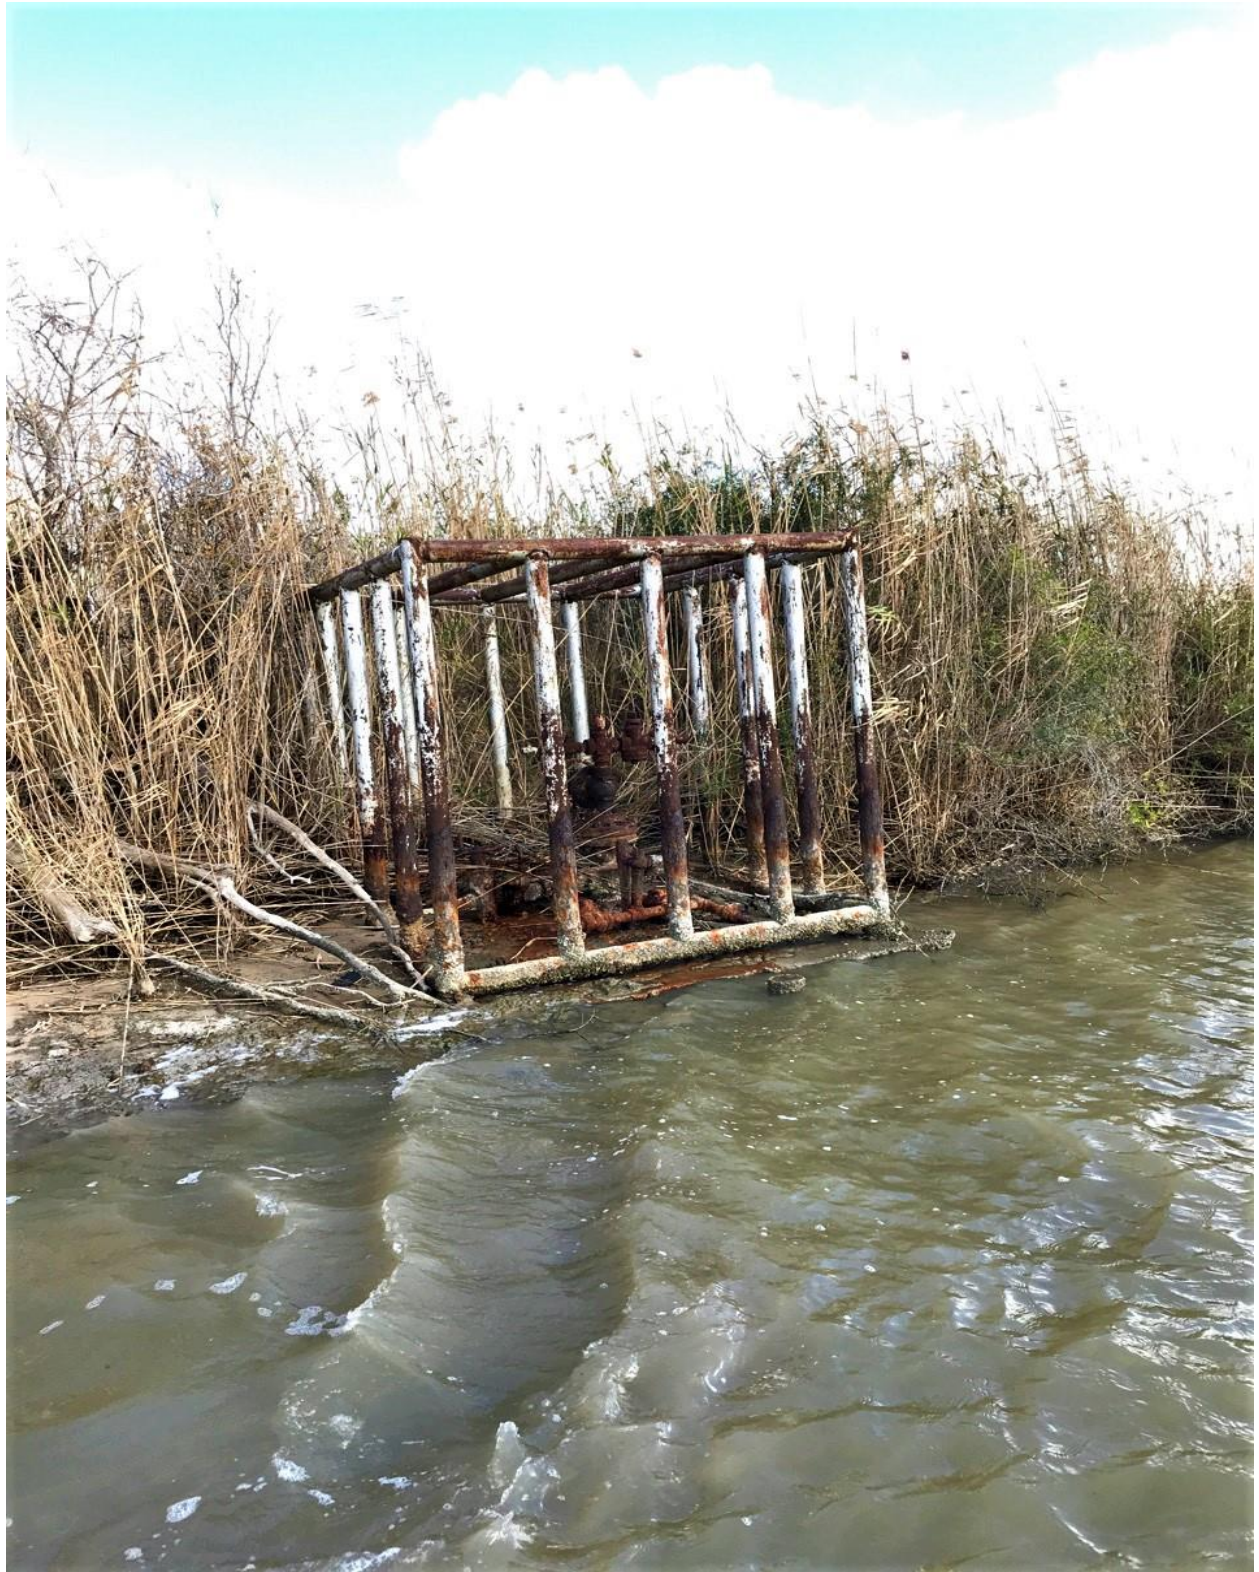
Figure 9: Abandoned Oil Well Number Two.

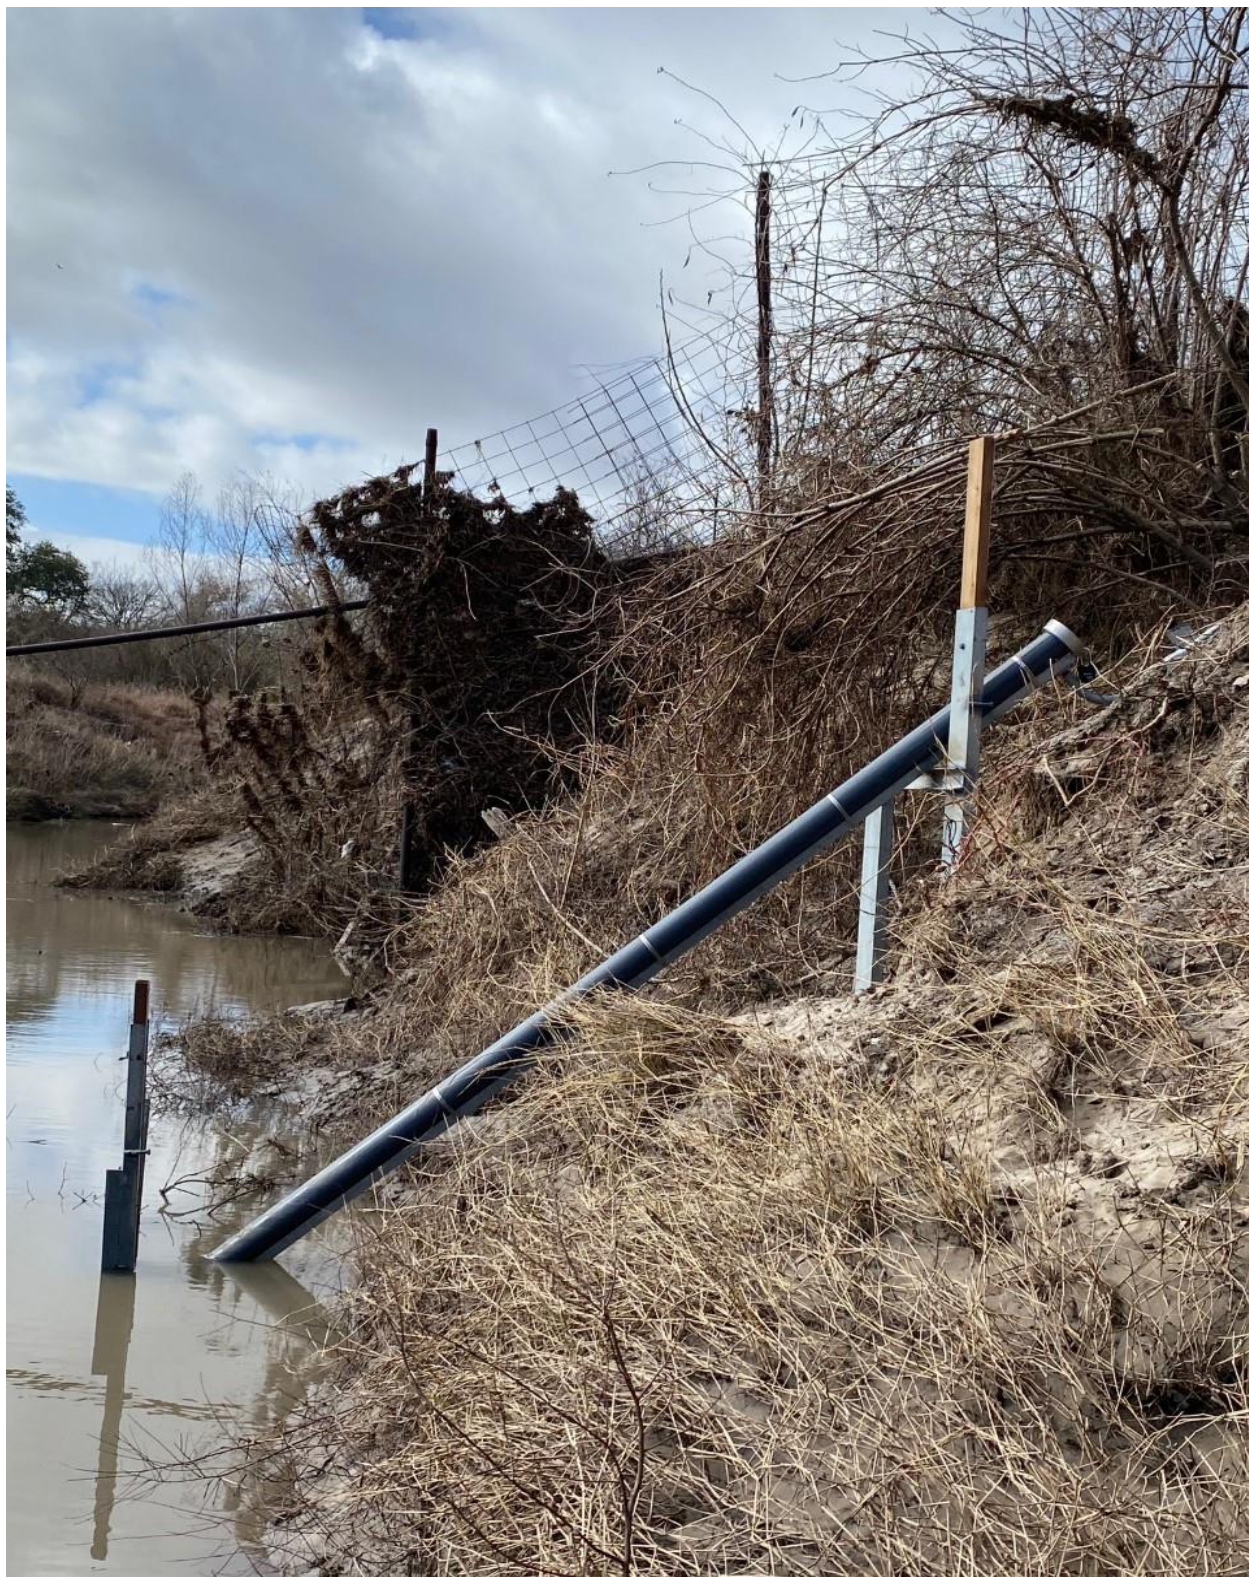
Figure 13: Turbidity Probe On East Mustang Creek.

In 2020, LNRA contracted with the United States Geological Survey (USGS) to install and maintain a turbidity sensor on East Mustang Creek. Turbidity is a measure of water clarity or light transmitting properties. An increase in turbidity can be caused by suspended matter such as clay, silt, and other microscopic organisms. The USGS installed the turbidity sensor at the existing gauge house on East Mustang Creek. The sensor was installed to collect daily turbidity values of water which will flow into the Mustang Arm of Lake Texana. LNRA will monitor the sediment values in East Mustang Creek and come up with the best management practices to help reduce sediment loads entering the reservoir.

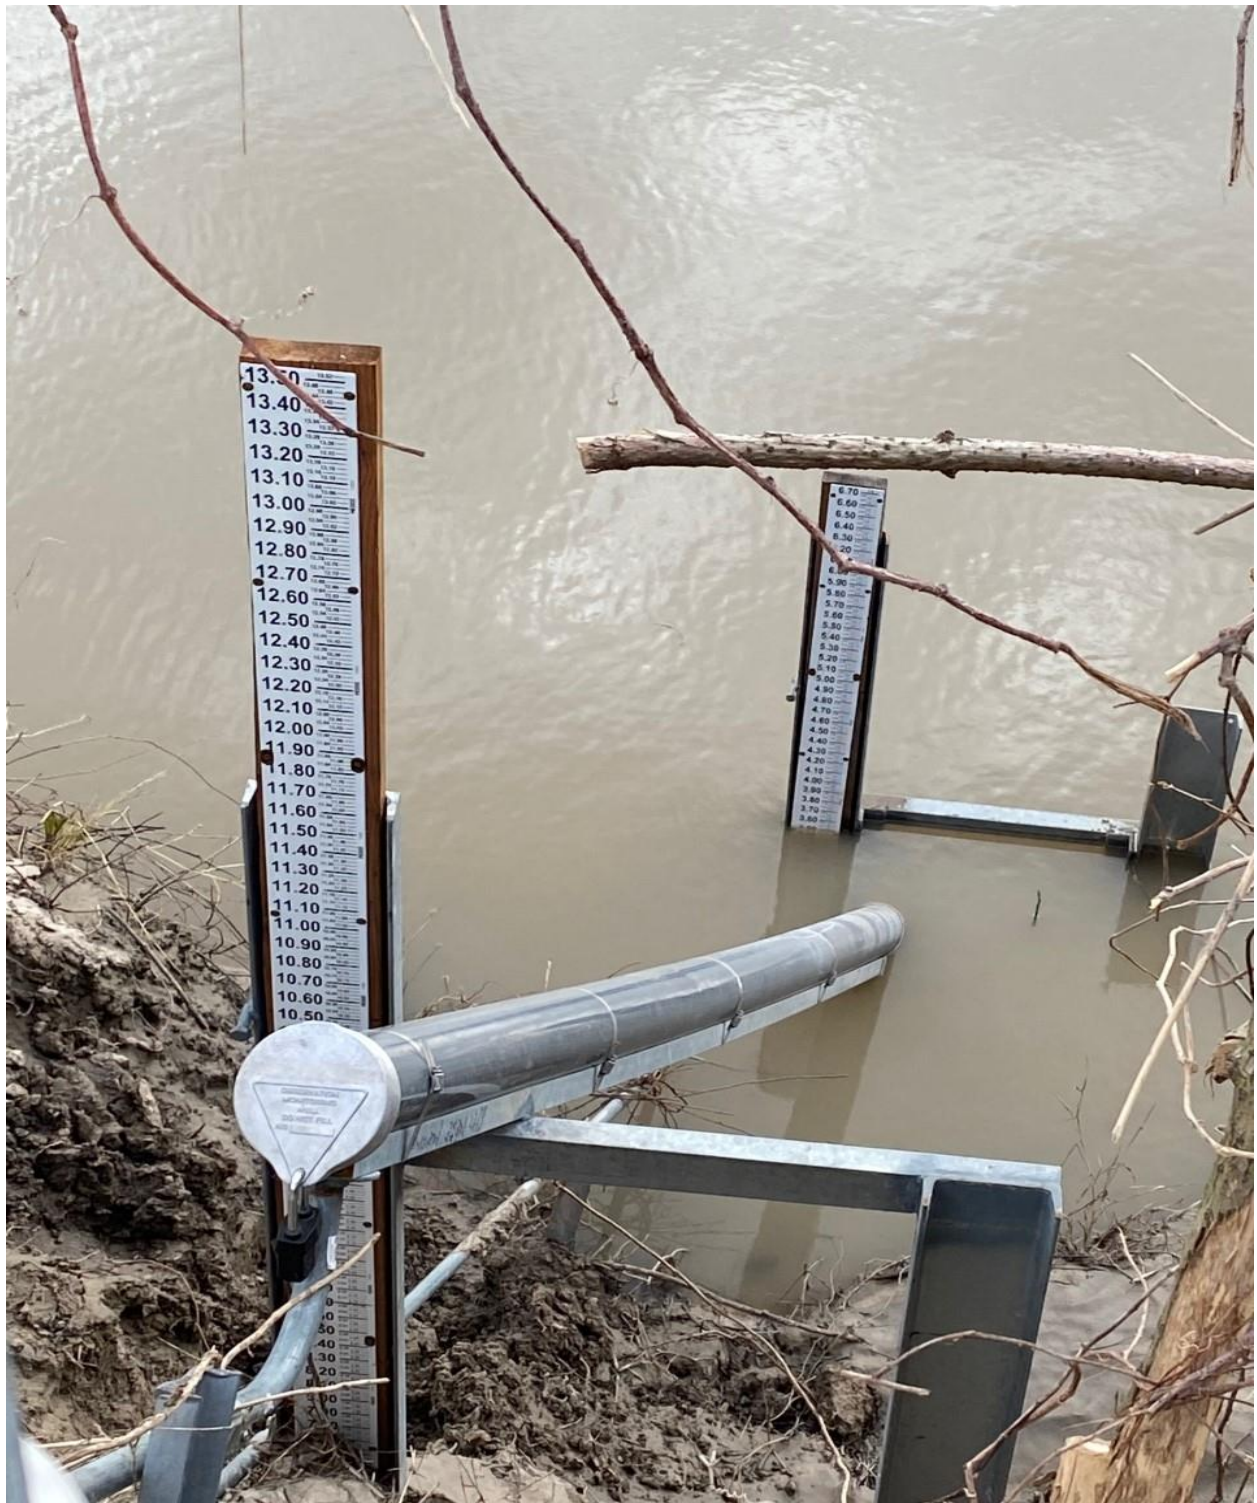
Figure 14: Turbidity Probe On East Mustang Creek.

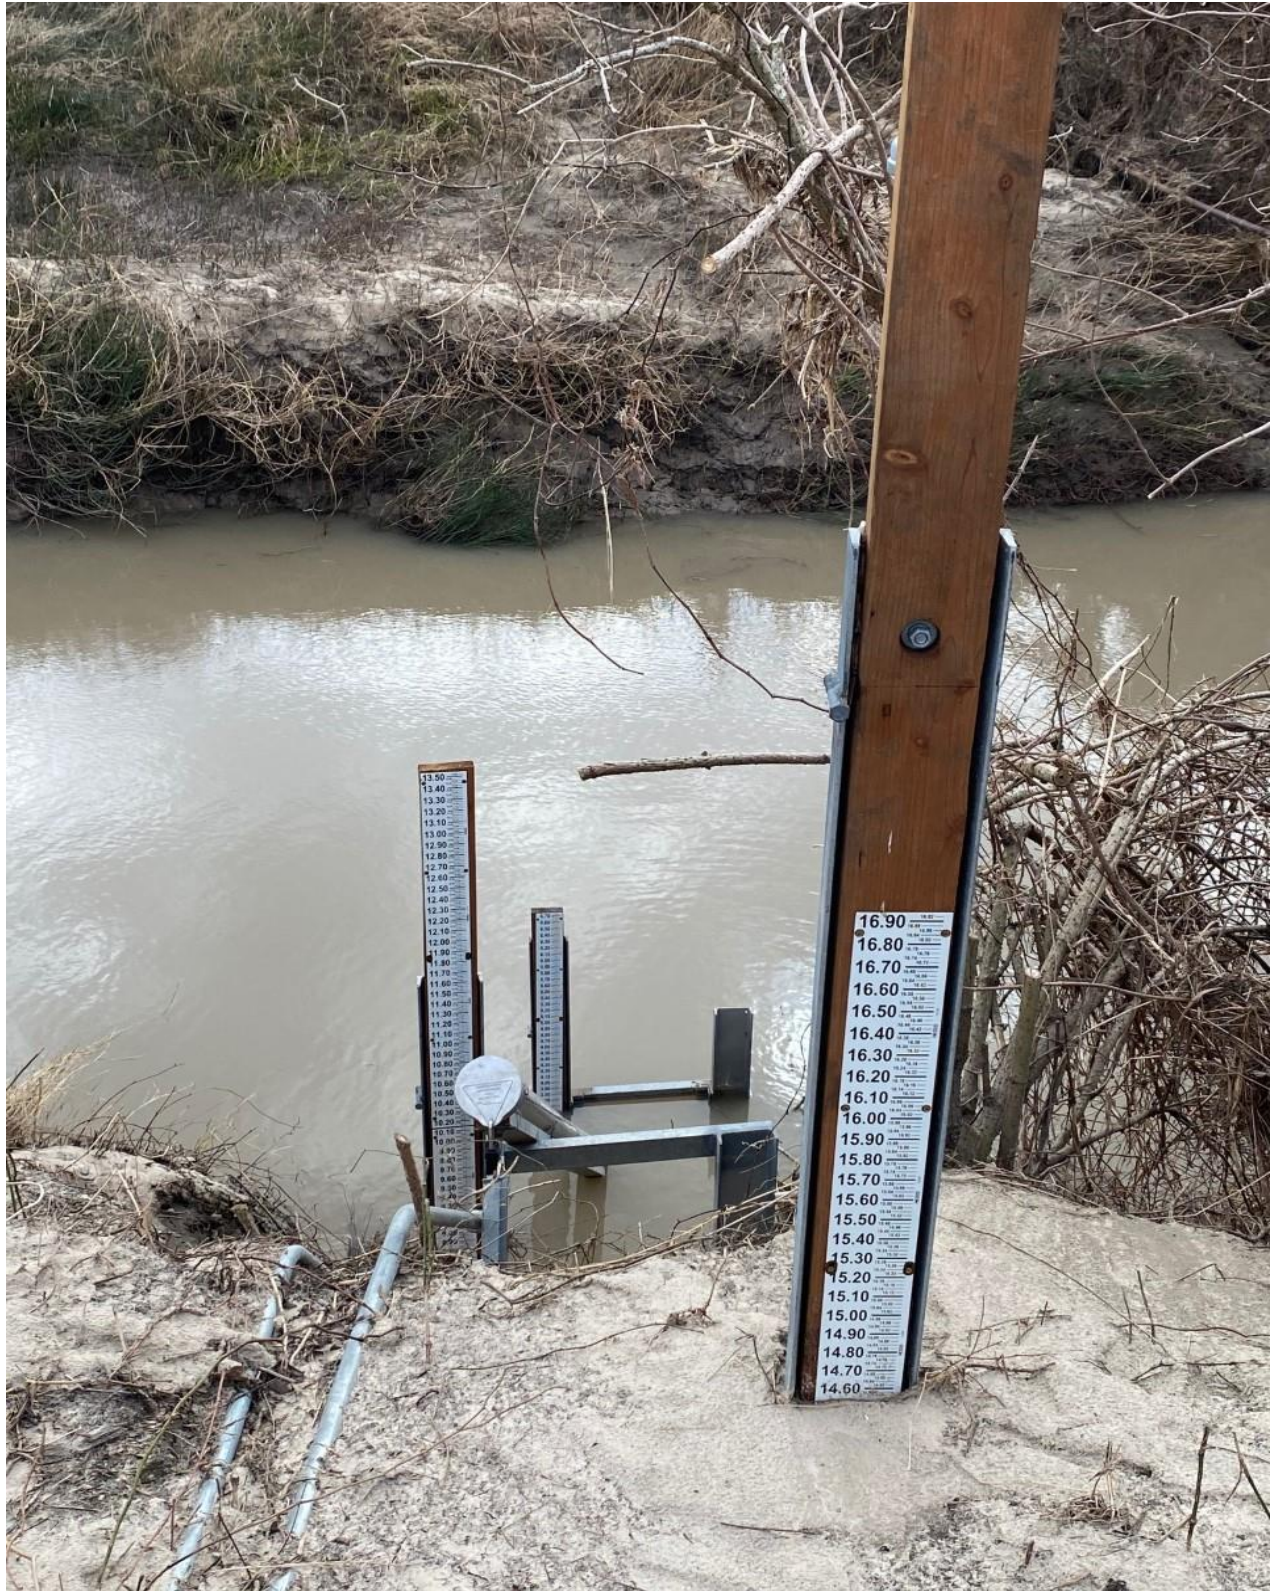
Figure 15: Turbidity Probe On East Mustang Creek.
