# 2022 LAVACA BASIN SUMMARY REPORT

**LNRA**  
LAVACA-NAVIDAD  
RIVER AUTHORITY

Water Monitoring Solutions.

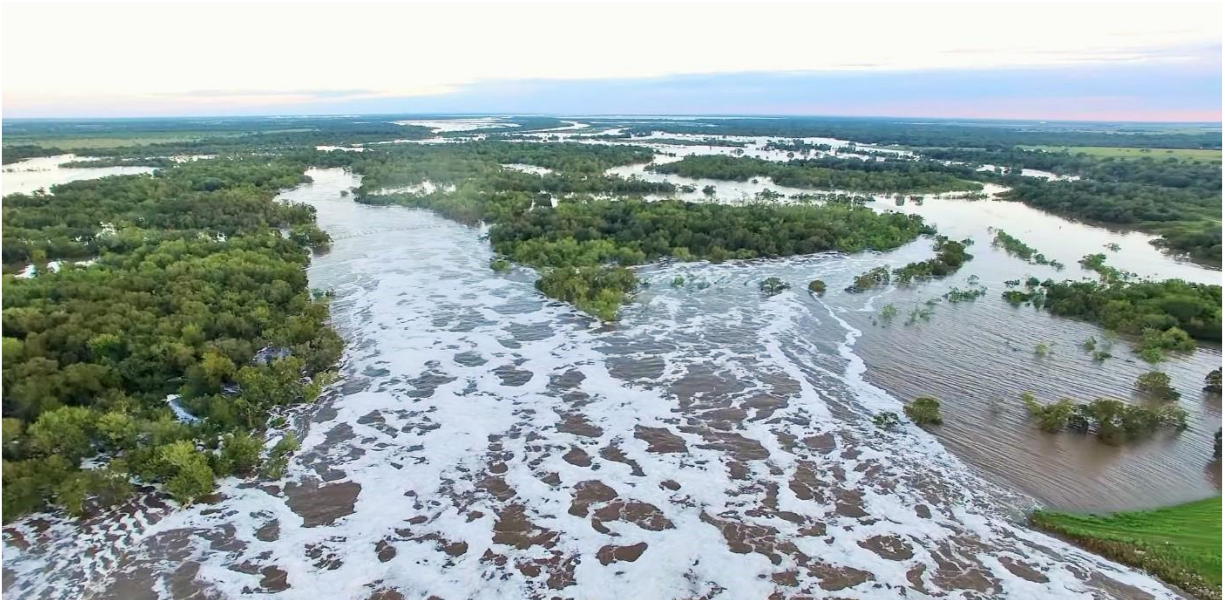
*Figure 9: Water released from the Palmetto Bend Dam spillway into the Navidad River, Segment 1603, after Hurricane Harvey*

Due to flooding from Harvey, LNRA released 70,344 cubic feet per second (cfs) of water, with a total volumetric discharge of 478,122 acre-feet. Considering that Lake Texana has a storage capacity of 161,085 acre-feet, approximately three times the reservoir's capacity was released. While Hurricane Harvey devastated many areas with high winds and torrential rainfall, the Lavaca Basin was mostly spared.
