Lavaca Basin

2023 Water Quality Update

*Prepared by the
Lavaca-Navidad River Authority (LNRA)
PO Box 429, Edna, TX 77957*

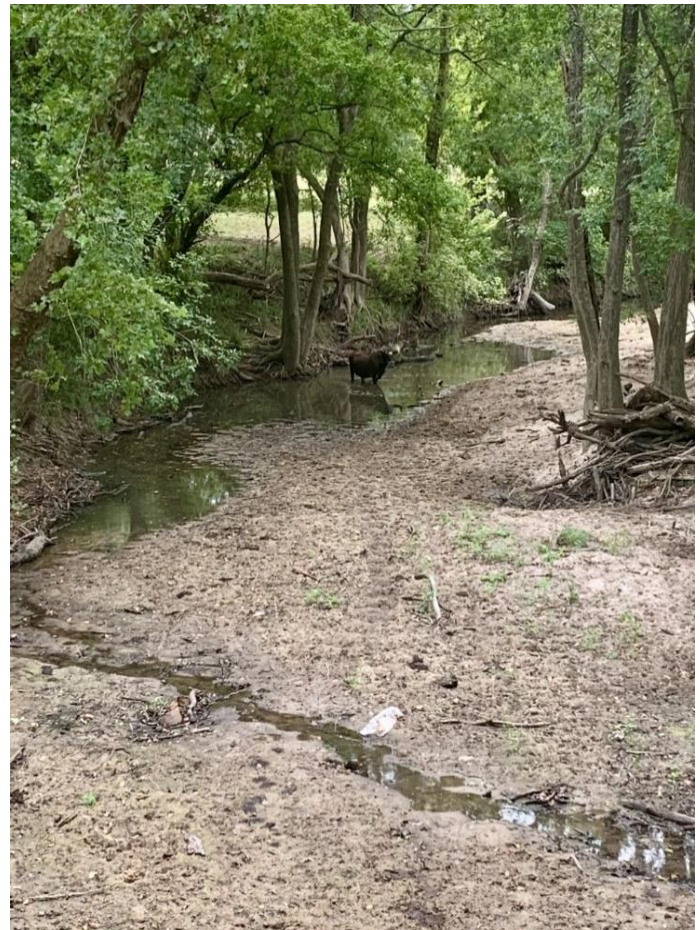
Figure 2: Cow in the Navidad River at CR 142

There are a variety of factors that may contribute to elevated bacteria levels within the stream. Examples include livestock, wildlife, failure of onsite sewage facilities, and stormwater runoff. This BST study is working in conjunction with the ongoing Lavaca Watershed Protection Plan (WPP) to reduce the bacteria level below the State's criteria.

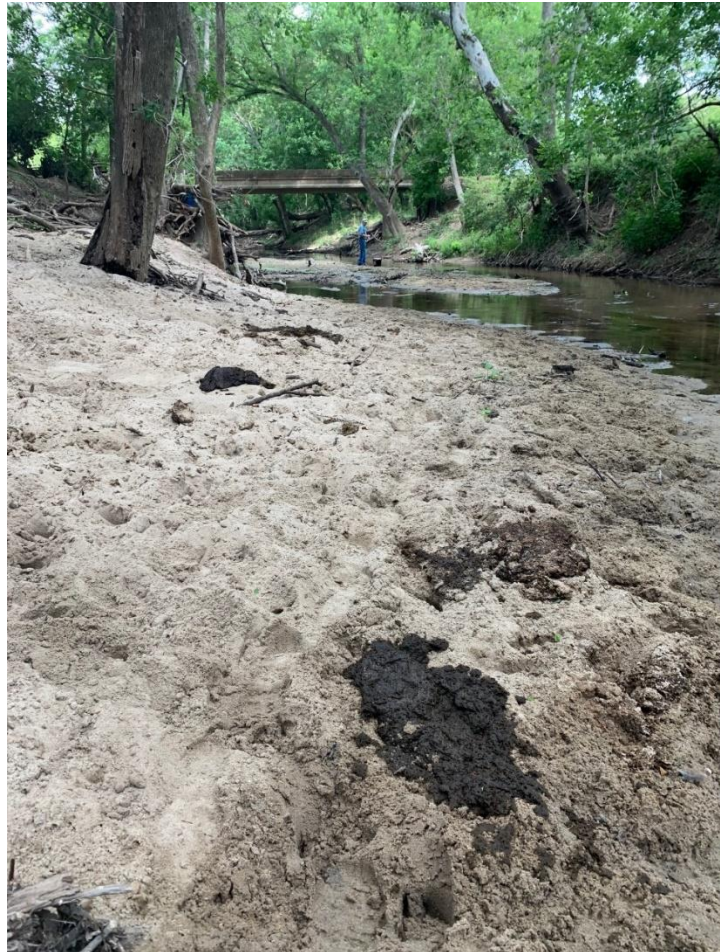
Figure 3: Cattle manure in Navidad River at CR 142

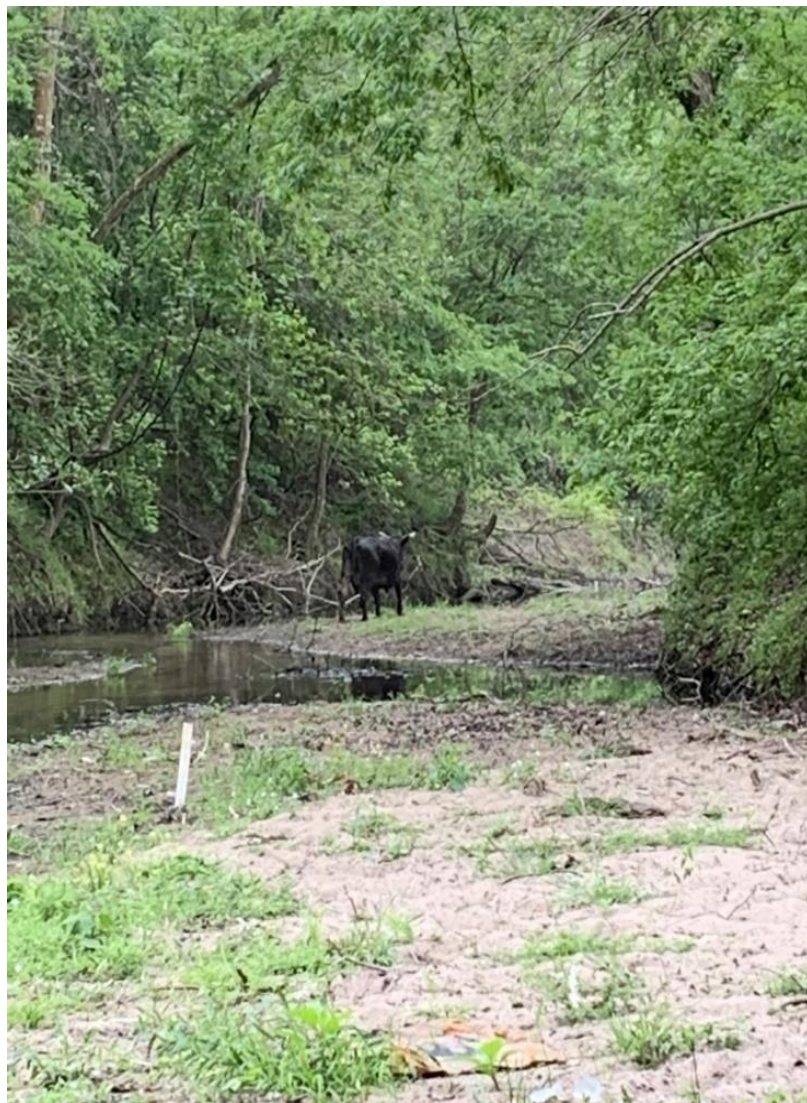
Figure 4: Cow in Rocky Creek

Unclassified Segment 1602B – Rocky Creek was added to the §303(d) List for bacteria in 2014; the 2022 IR reported a geometric mean of 339.8 MPN/100 mL. Cattle are a regular sighting in the stream and could be a likely source of bacteria through direct deposition. While feral hogs have not been sighted in the river, evidence of activity has been seen.

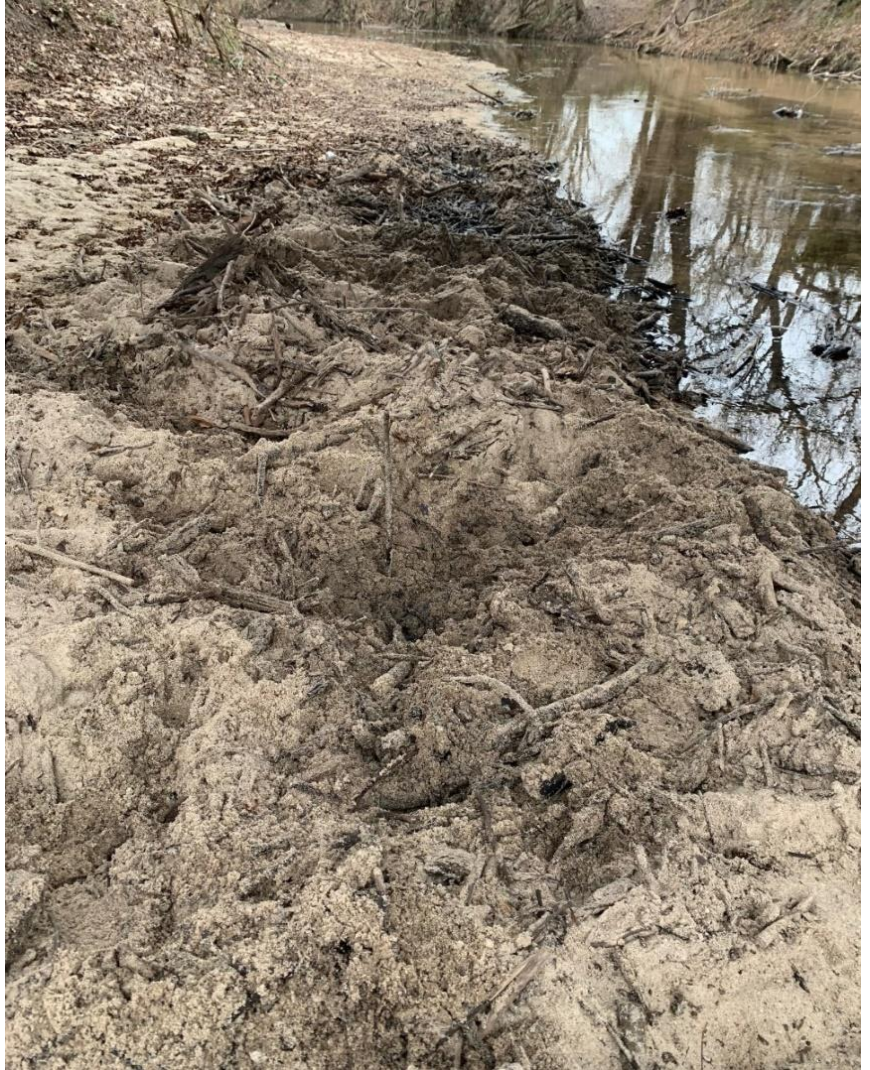
Figure 5: Feral hog activity in Rocky Creek

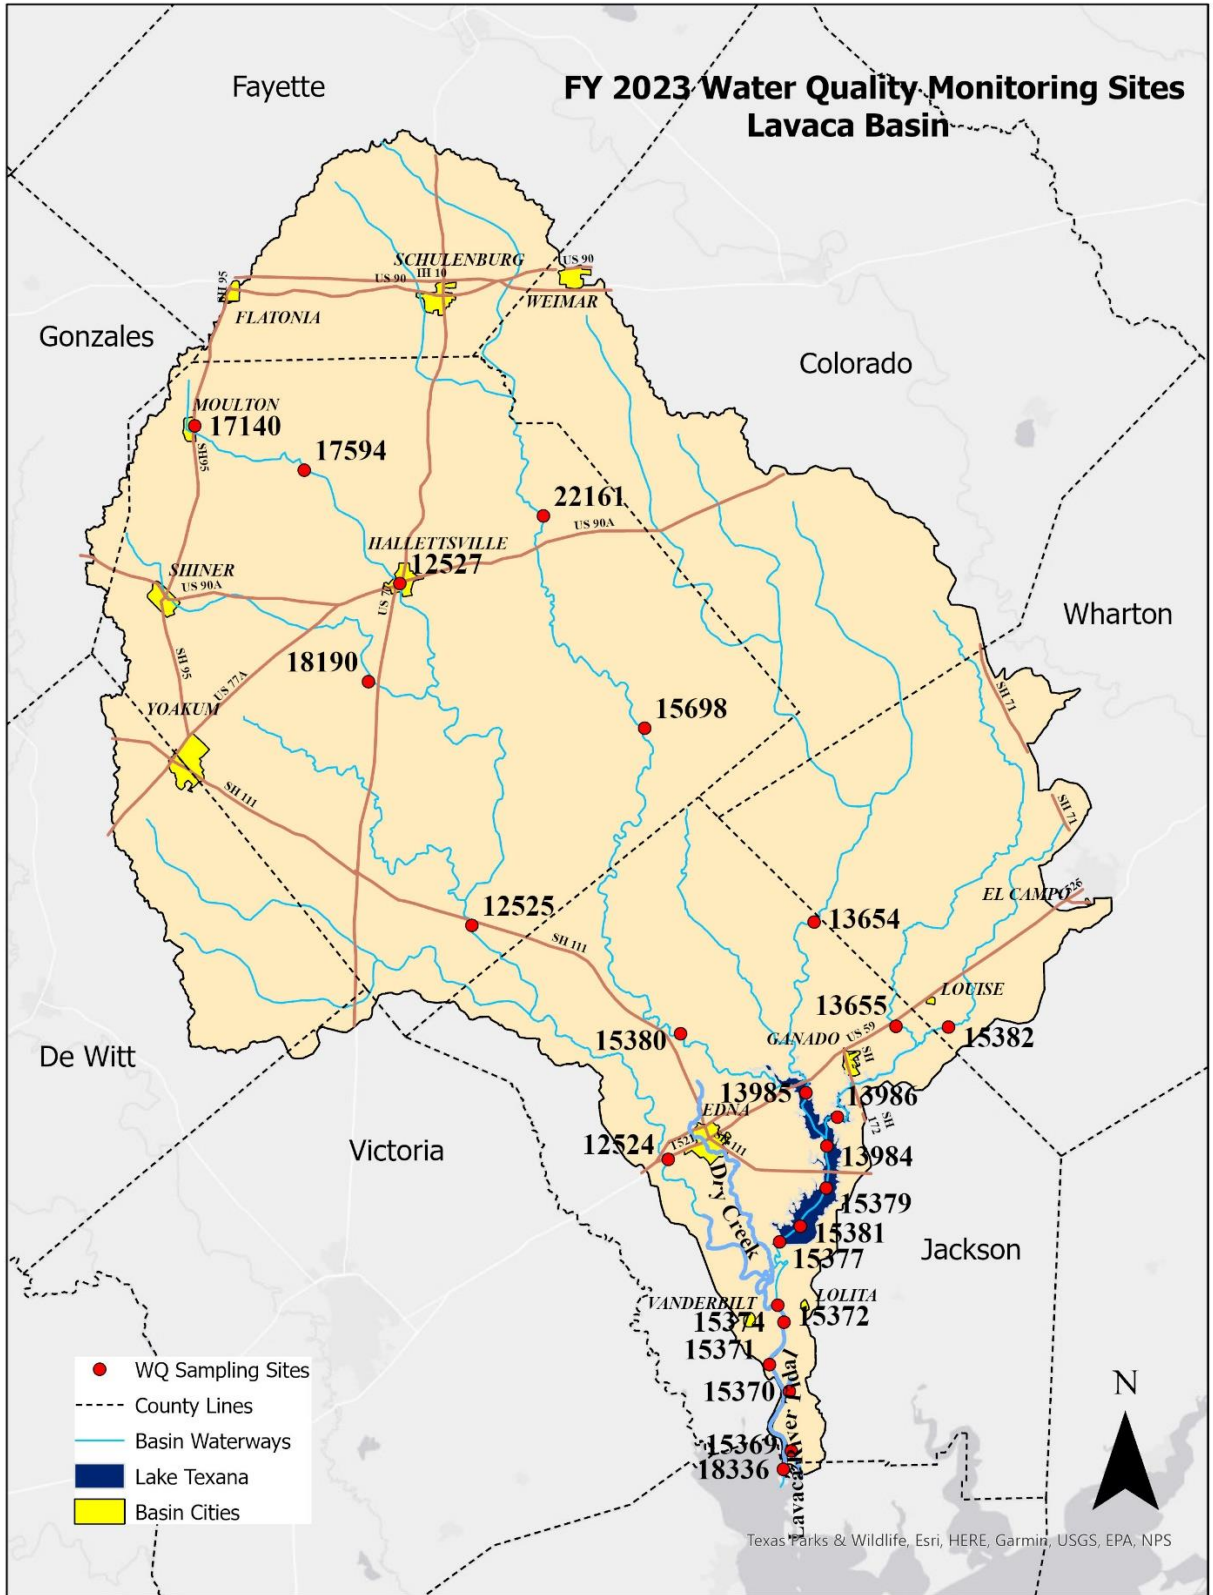
Figure 7: LNRA Monitoring Sites

LNRA holds a coordinated monitoring meeting with entities collecting water quality data in the Basin annually to coordinate efforts and maximize limited resources available. Table 1 is a layout of the types and amounts of water quality monitoring that will be conducted in the Lavaca Basin. The data acquired includes a mixture of field, conventional, bacteriological, organics, and metals in water collected by LNRA and the United States Geological Survey (USGS). Data collected under the CRP can be found on the TCEQ CRP public viewer at <https://www80.tceq.texas.gov/SwqmisWeb/public/crpweb.faces>.
